Pliant Sponge Media[™] Abrasives and the Aerospace Industry:

Rain Erosion Coating Removal Utilizing Sponge Media[™] Abrasives

Barry S. Spigel, MS, Southwest Research Institute San Antonio, TX

Paper and Presentation at the 2000 DOD / Industry Aerospace Coatings Conference Norfolk Waterside Marriott, Norfolk, VA November 22-25, 2000

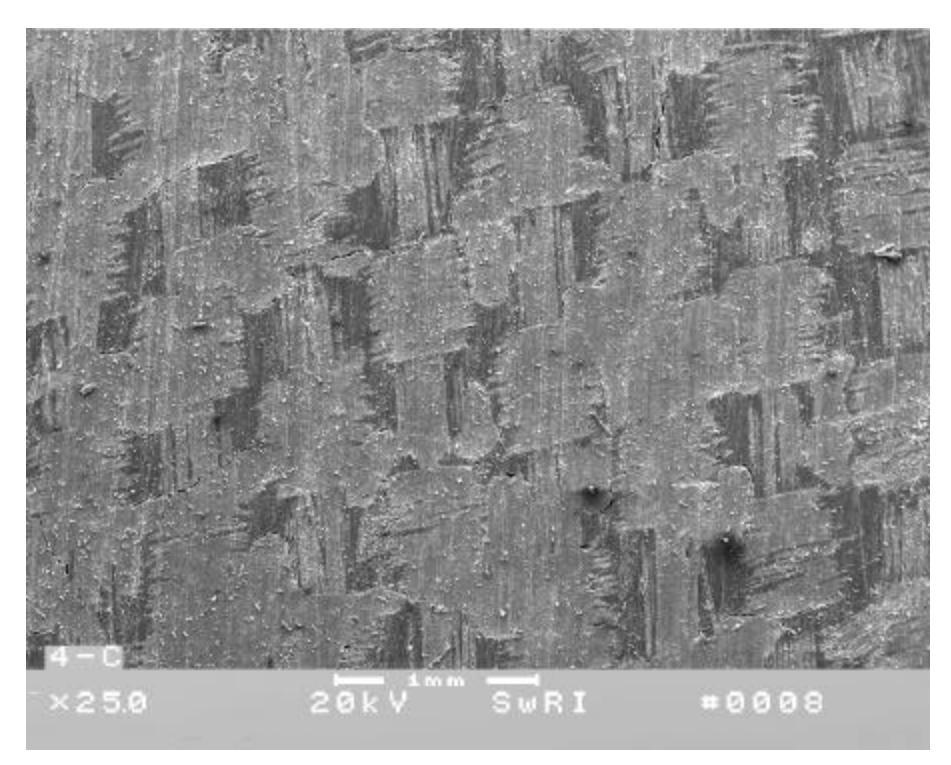
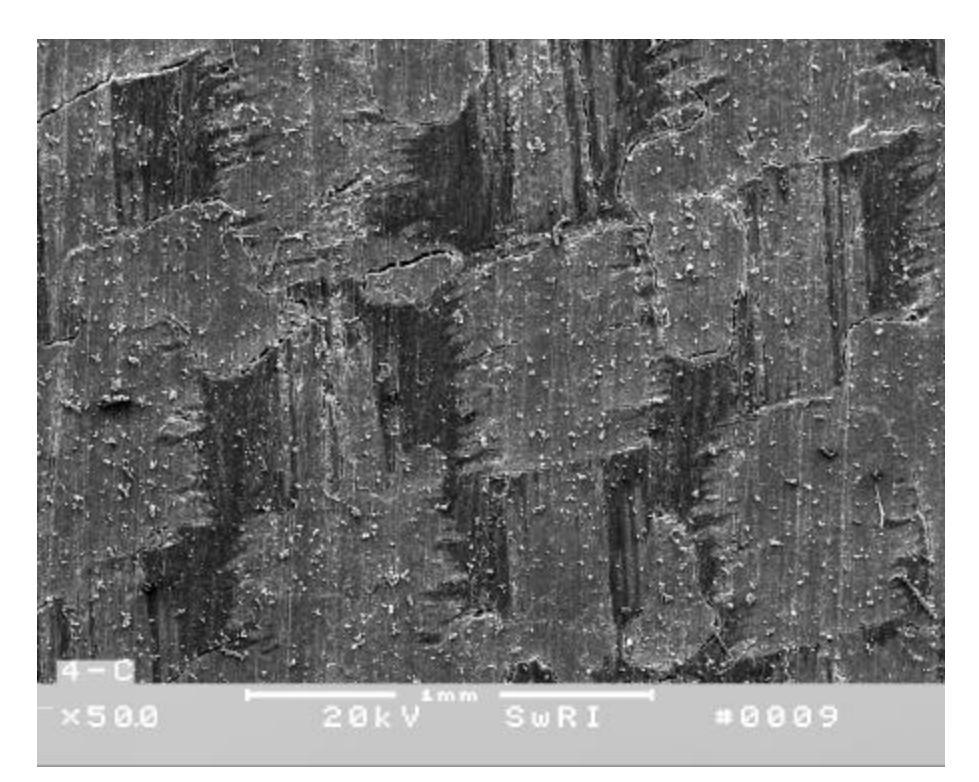
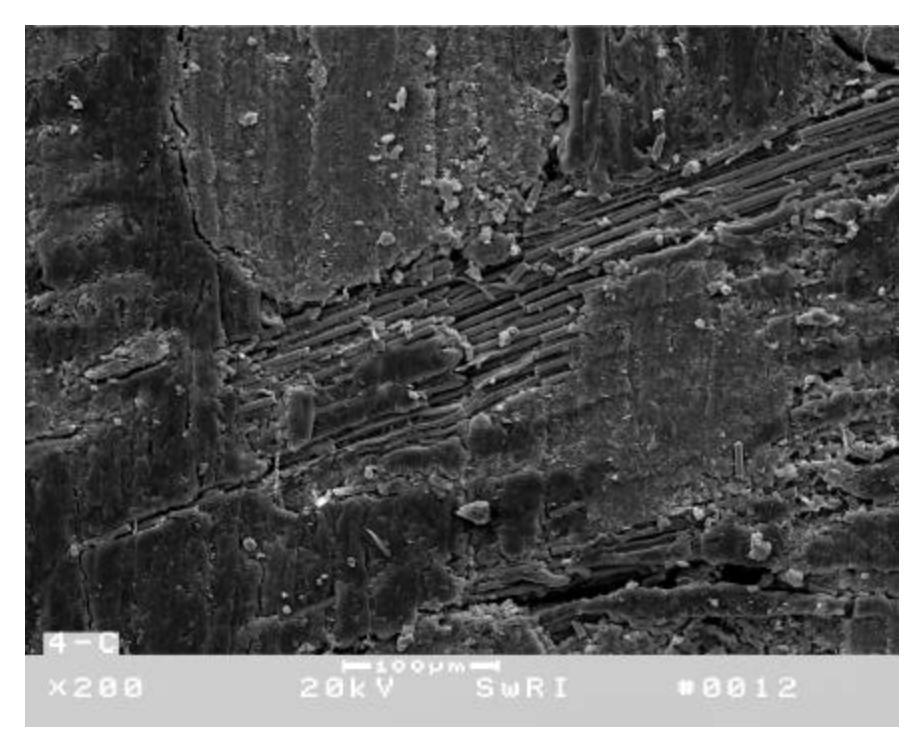
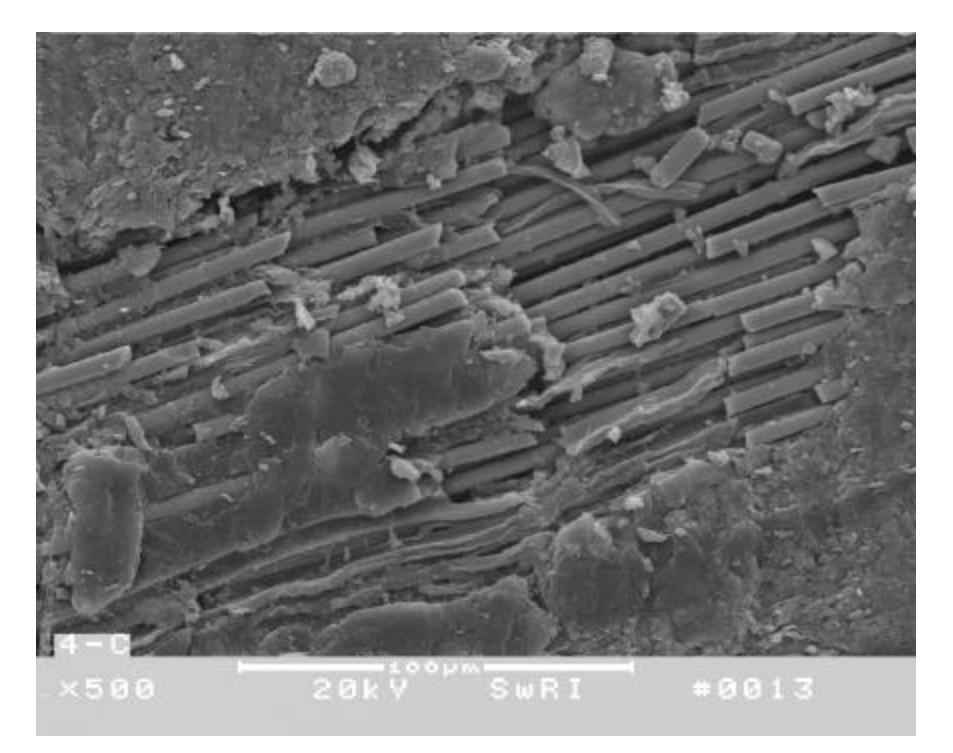
The SEM micrographs of the Panel 4 Control sample, 4-C, are shown in Figures 1 through 4. At 25X and 50X (Figures 1 and 2), the weave of the fiberglass cloth is clearly visible and few areas of exposed fibers are observed. Cracks can be seen in the resin layer, particularly at 50X. At 200X (Figure 3), some resin cracks and exposed fibers are seen, and at 500X (Figure 4), many of the exposed fibers are found to be broken. Particles of resin are evident on the surface at 200X and 500X. Although it may be assumed that the resin deteriorated due to the chemical stripper, the presence of the broken fibers is likely due to in-service rain erosion damage and/or previous removal of the radome coatings by scuff-sanding or other means.

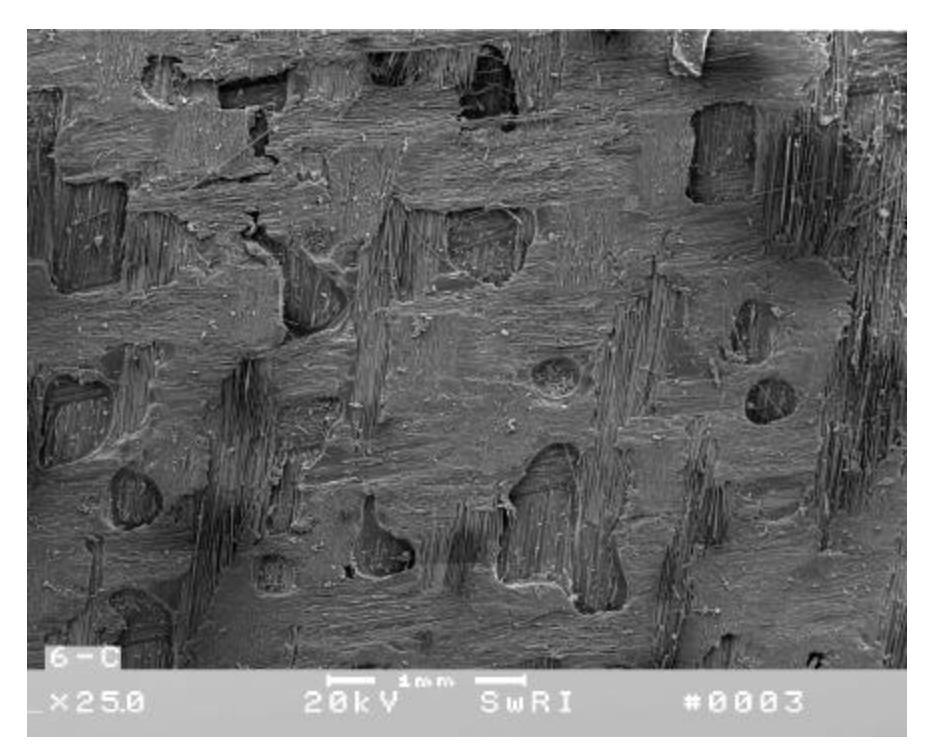
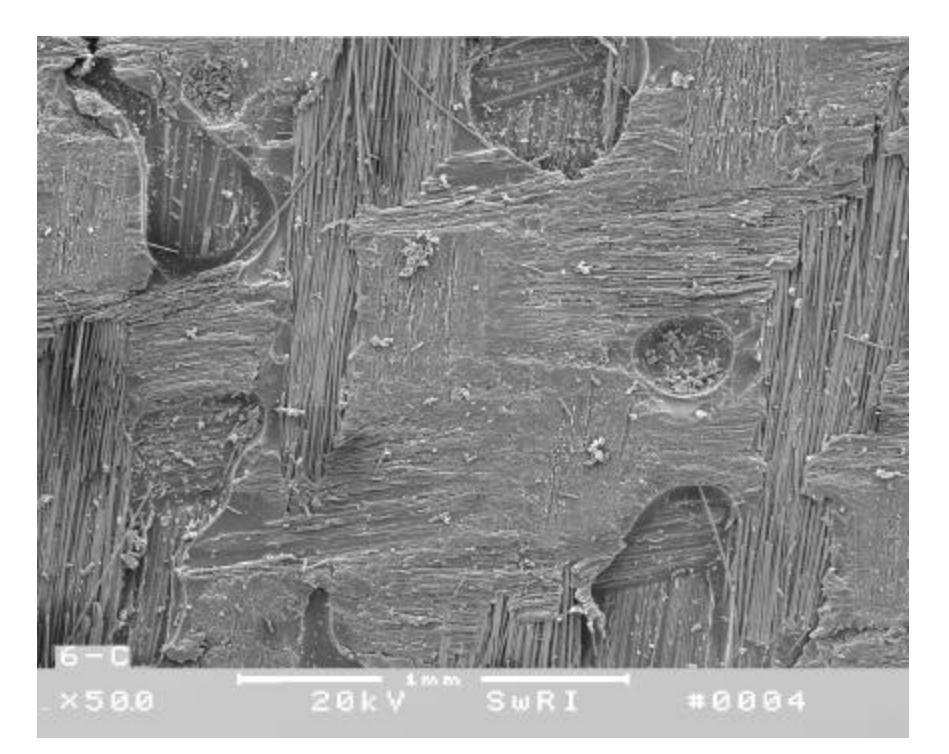
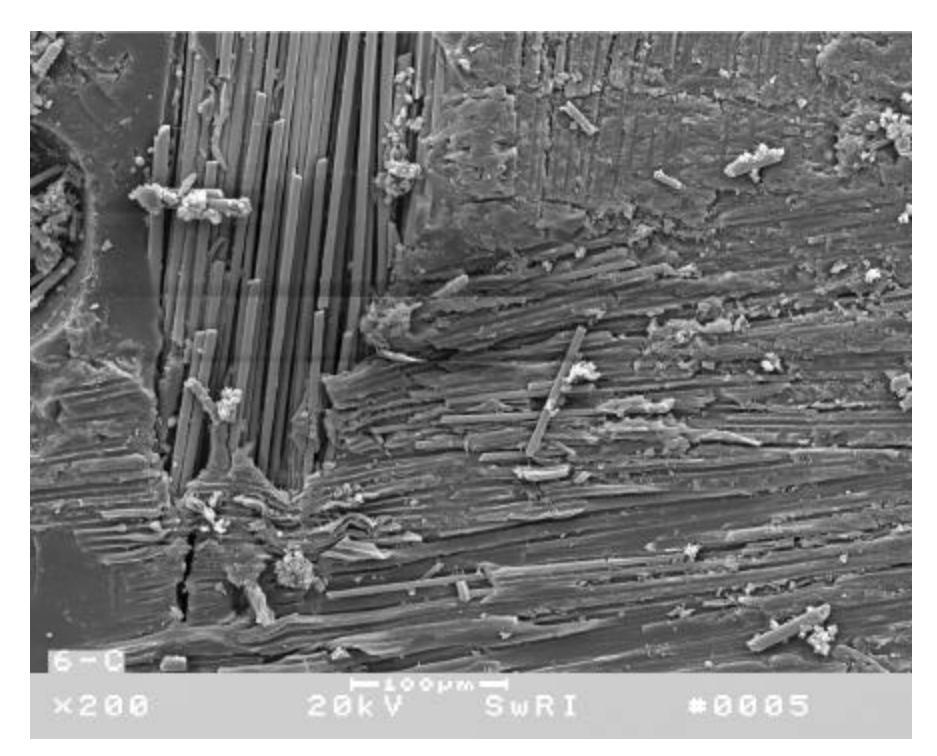
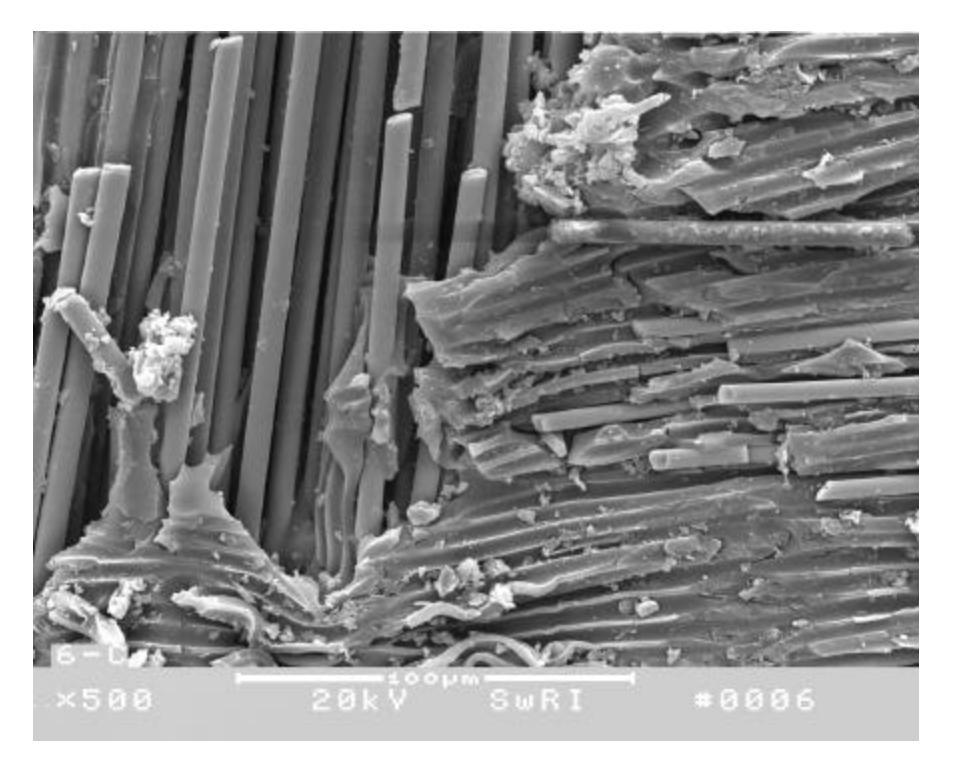
The Panel 6 Control sample, 6-C, had more damage than Sample 4-C. As seen at 25X and 50X (Figures 5 and 6), the weave pattern is still evident but more resin is missing and the majority of fibers are exposed to the surface. Again, some of the damage may be due to the chemical stripper, but it is likely that the multitude of pits in the surface resulted from rain impacts because the depth and magnitude of the holes in the resin layer were not observed in the Panel 4 Control sample that had been subjected to the same chemical stripper. At 200X and 500X (Figures 7 and 8), broken fibers throughout the weave are noted.

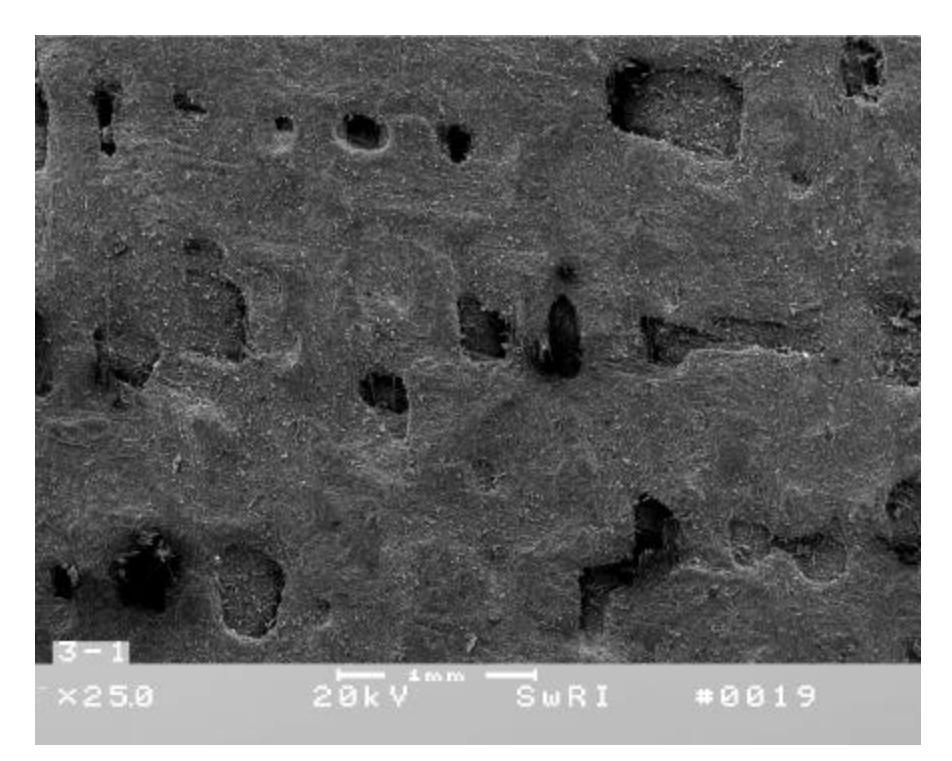
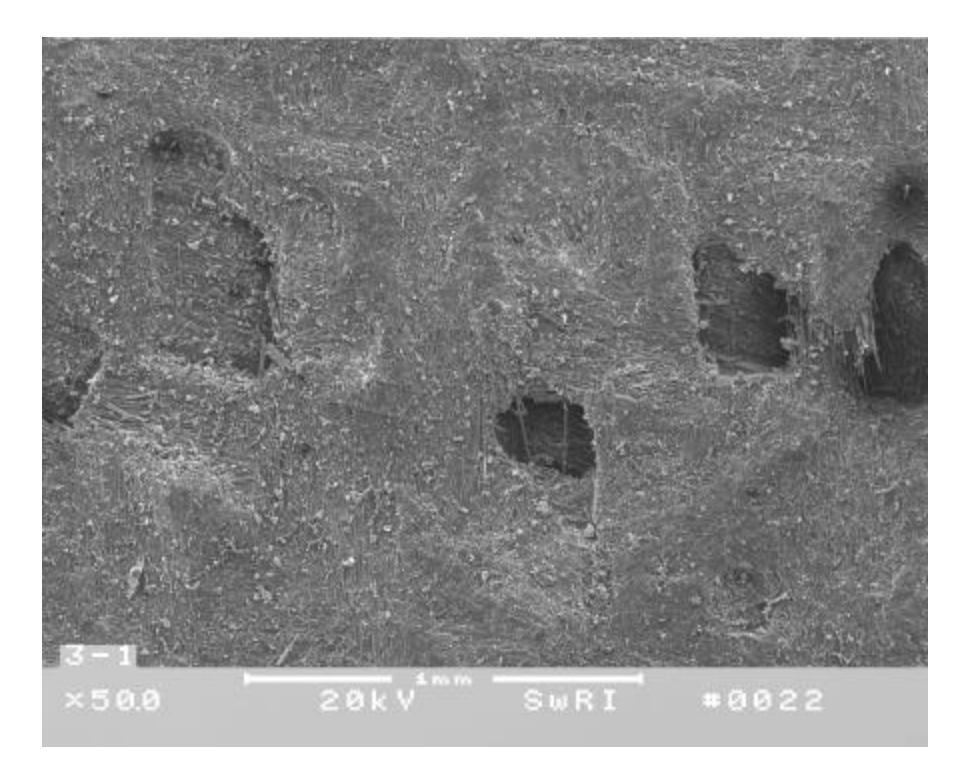
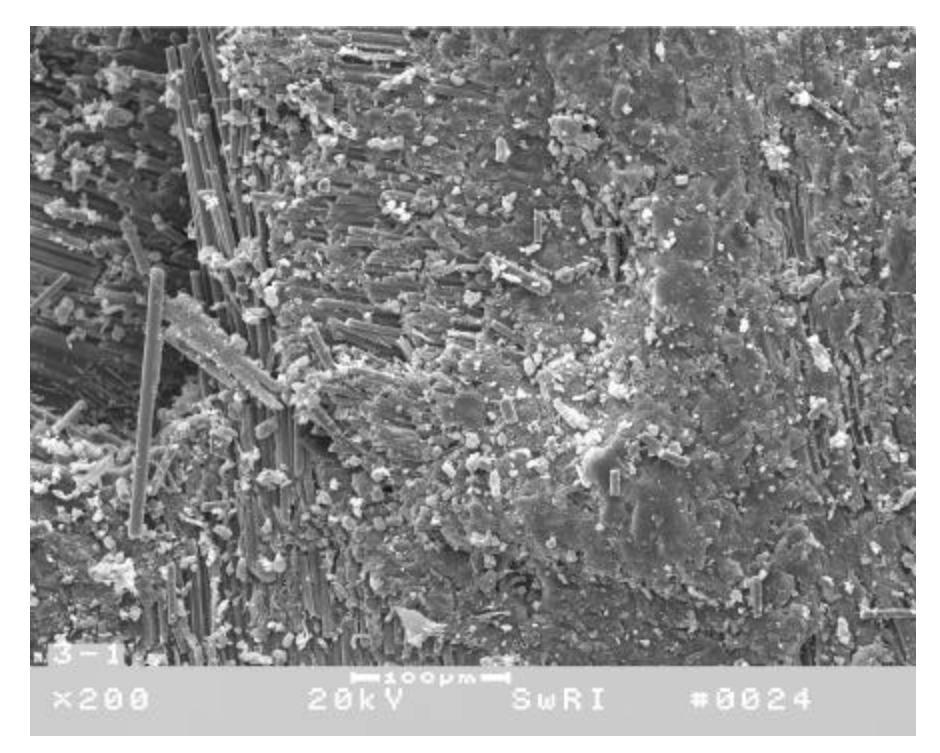
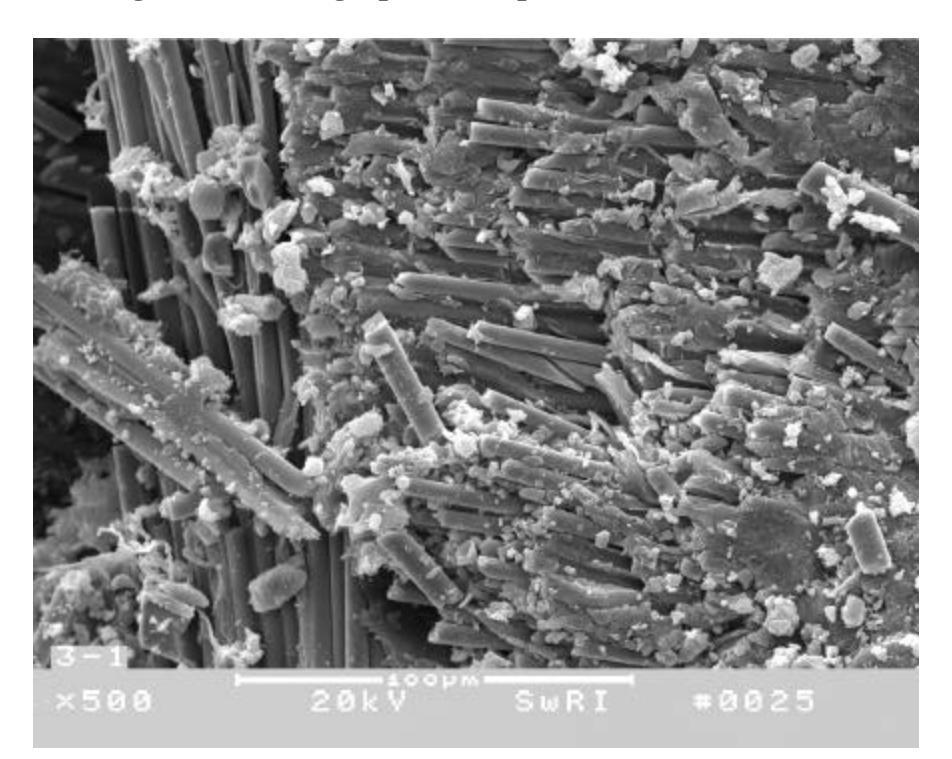
Figures 9 through 12 show the surface of SEM Sample 3-1. This sample had only red primer on the surface, and had been stripped to the bare fiberglass using aluminum oxide media. Extensive pitting is observed at 25X and 50X (Figures 9 and 10), and is similar to the conditions seen in Sample 6-C. The causes of the pitting and the broken fibers around the pits are unknown. However, visual examination of the unstripped regions of Panel 3 showed similar surface features and roughness, indicating that the aluminum oxide media likely did not cause the pits and broken fibers.

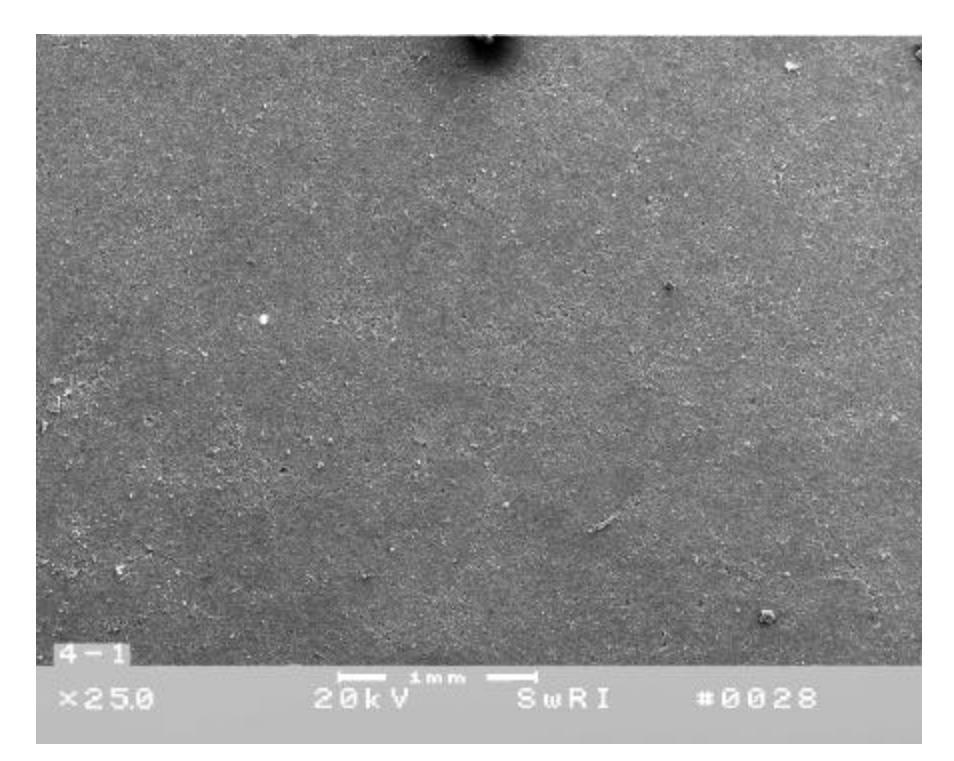
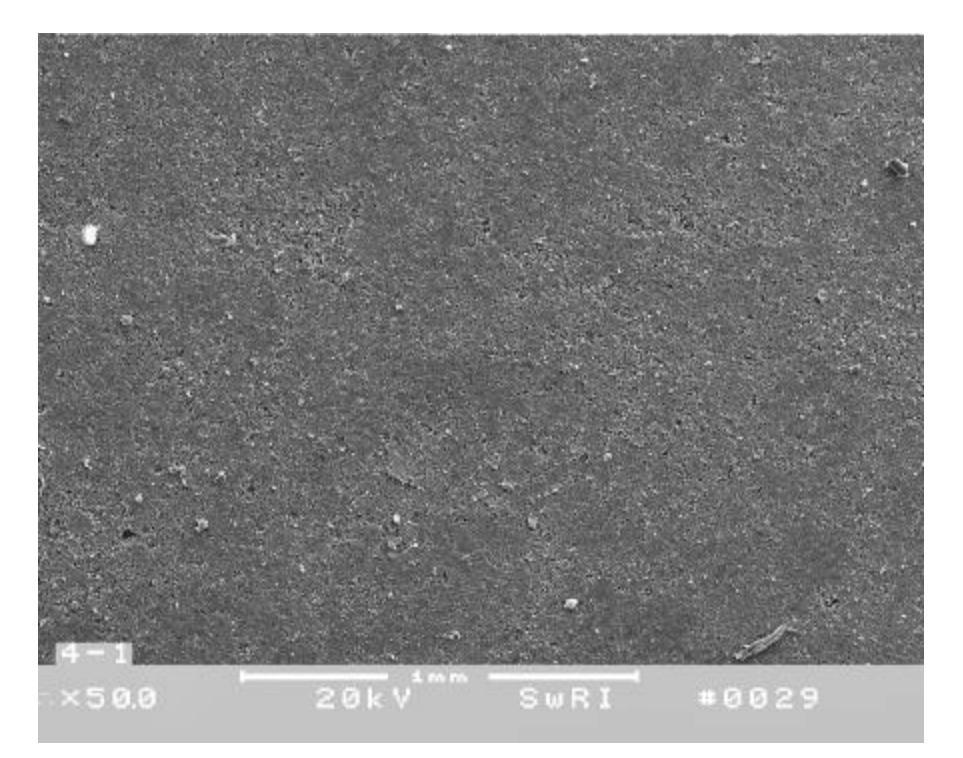
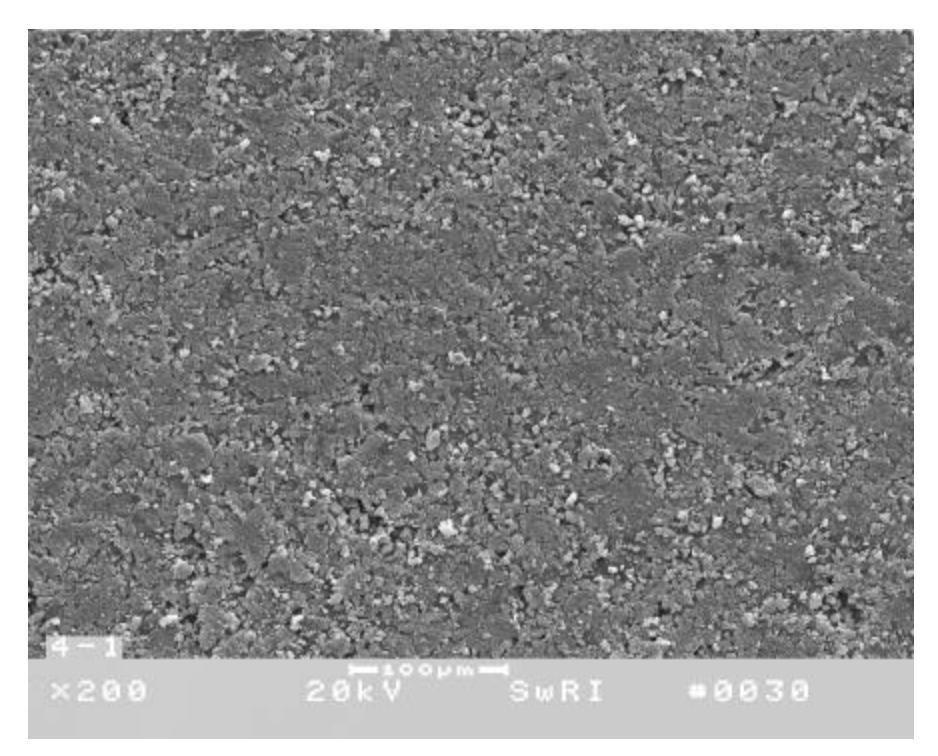
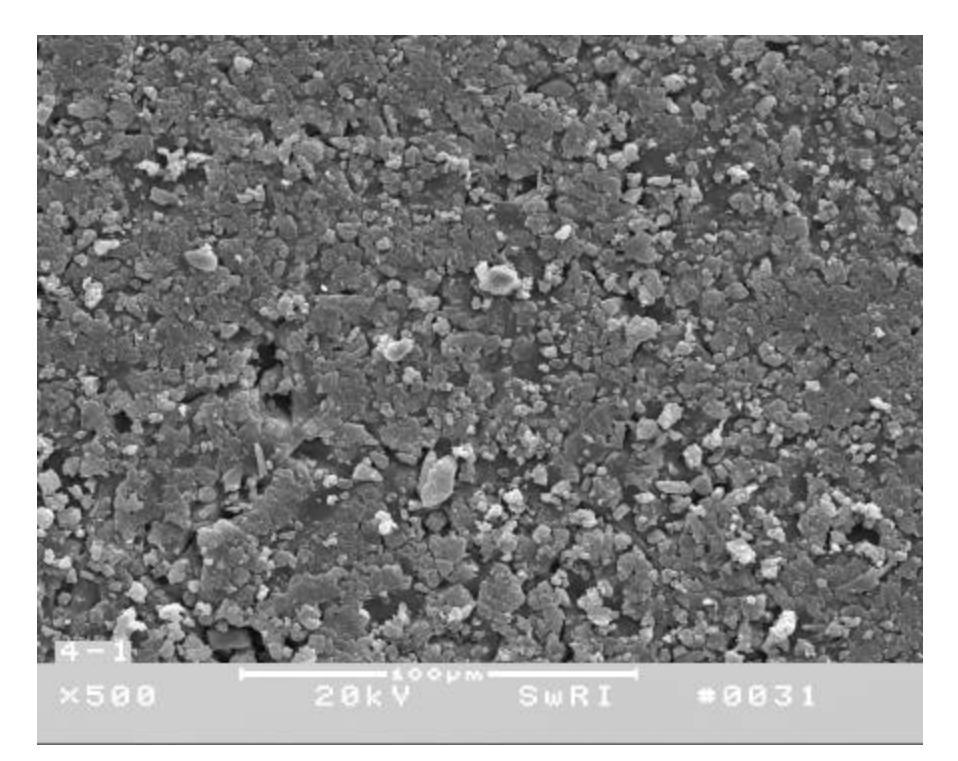
Sample 4-1 had the gray topcoat selectively stripped, leaving the black rain erosion coat exposed. Figures 13 through 16 are micrographs of the surface. These figures are relatively unremarkable since the surface is relatively smooth and undisturbed. No pitting of the rain erosion coating is observed in any of the micrographs. These figures indicate that the aluminum oxide sponge jet may be used to selectively strip a topcoat without damaging the underlying coating.

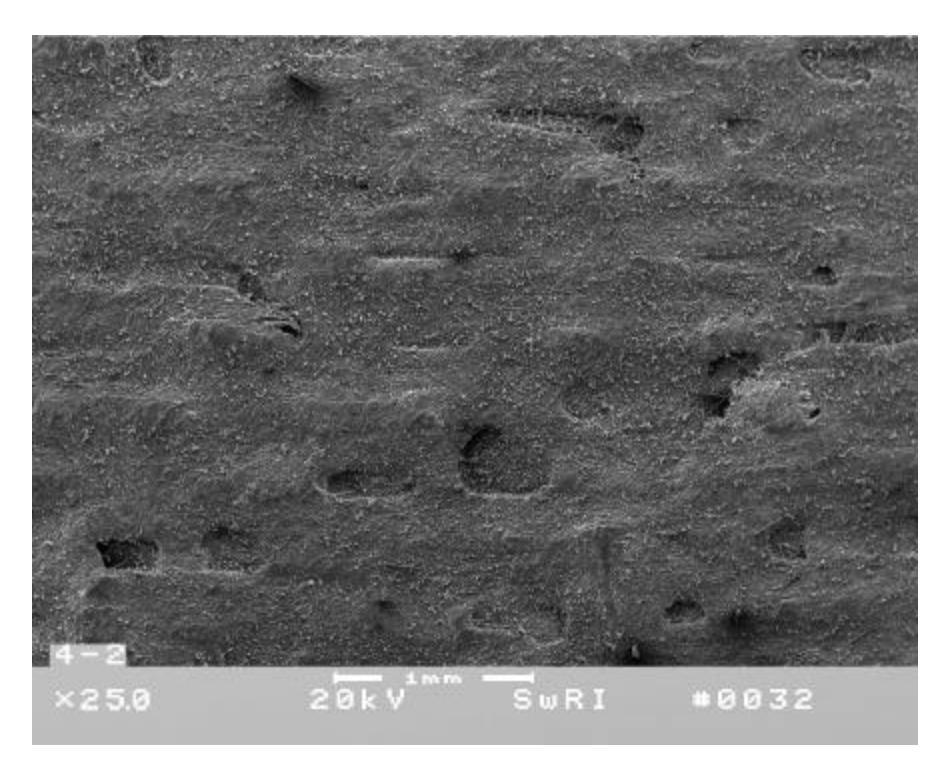
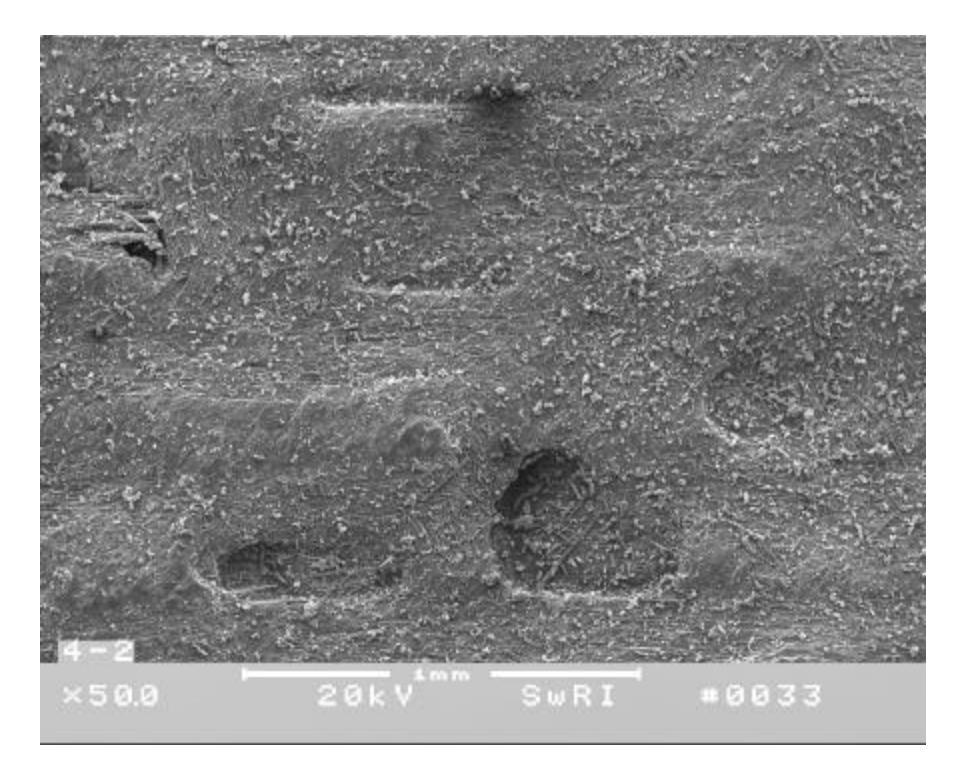
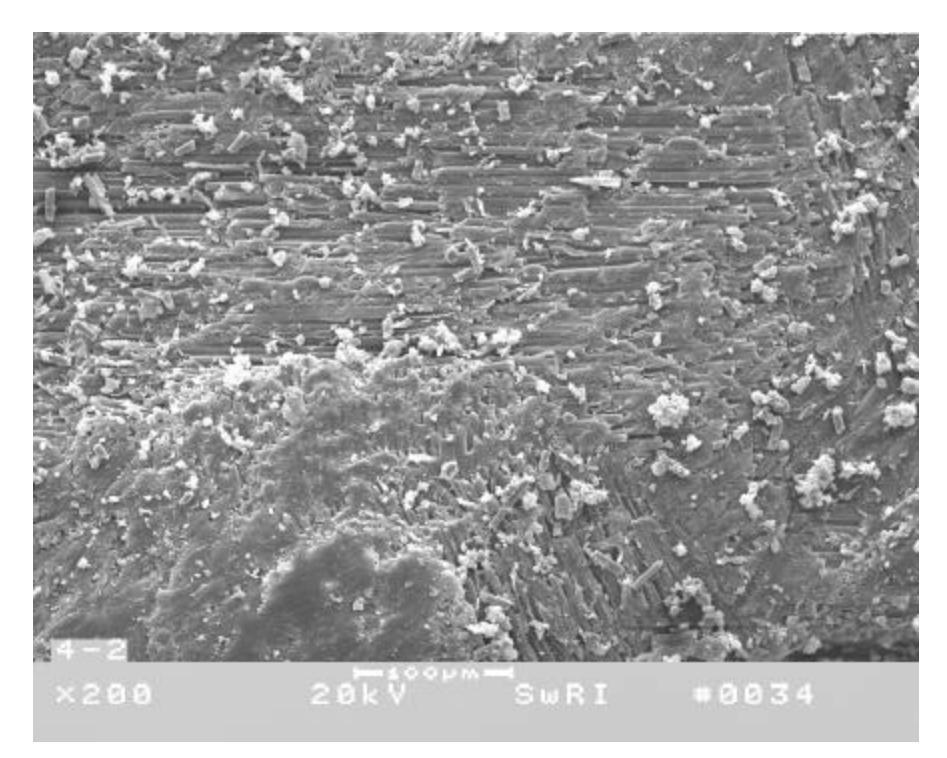
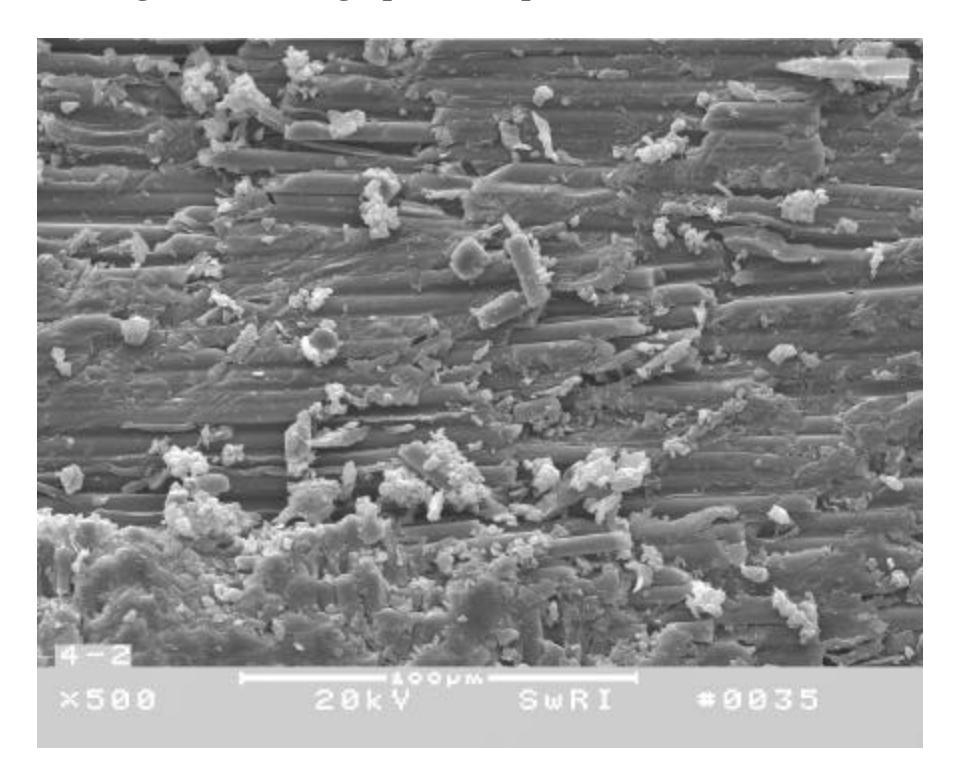
Figures 17 through 20 show the surface of SEM Sample 4-2. This sample was stripped to the bare fiberglass using the aluminum oxide media. At 25X and 50X (Figures 17 and 18), the surface is uniform, and there appears to be minimal resin loss. Some pitting of the resin surface is evident. Comparing these figures to Figures 1 and 2, Sample 4-C has more exposed fibers, less resin, and the weave of the fiberglass is evident. Aside from the pitting, the aluminum-oxide-stripped sample appears to show less damage than the chemically-stripped sample. At 200X and 500X (Figures 19 and 20), some exposed fibers are seen, but the number of broken fibers is minimal and there is little resin loss. It appears that the damage to the surface of the aluminum-oxide-stripped sample is no worse (perhaps less?) than the surface damage that resulted during in-service usage.

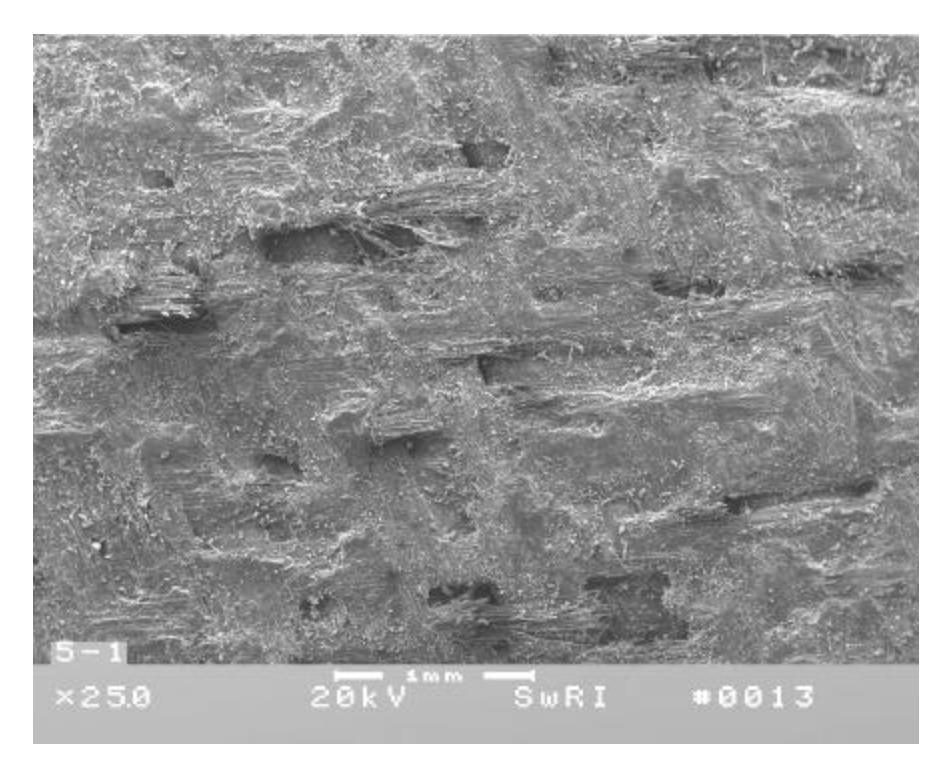
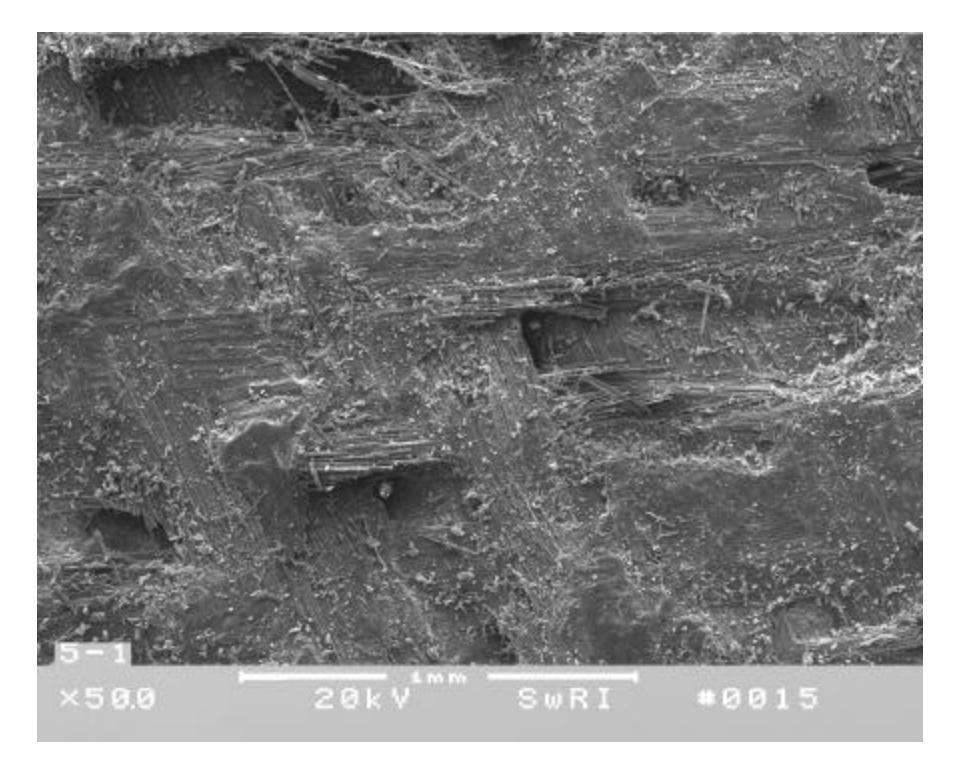
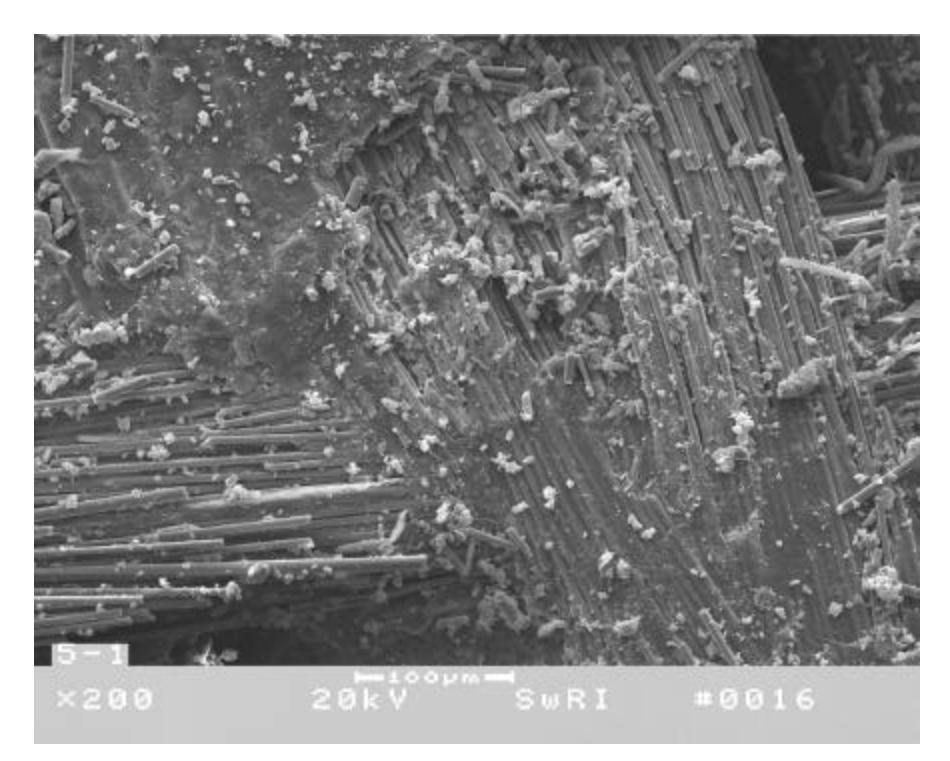
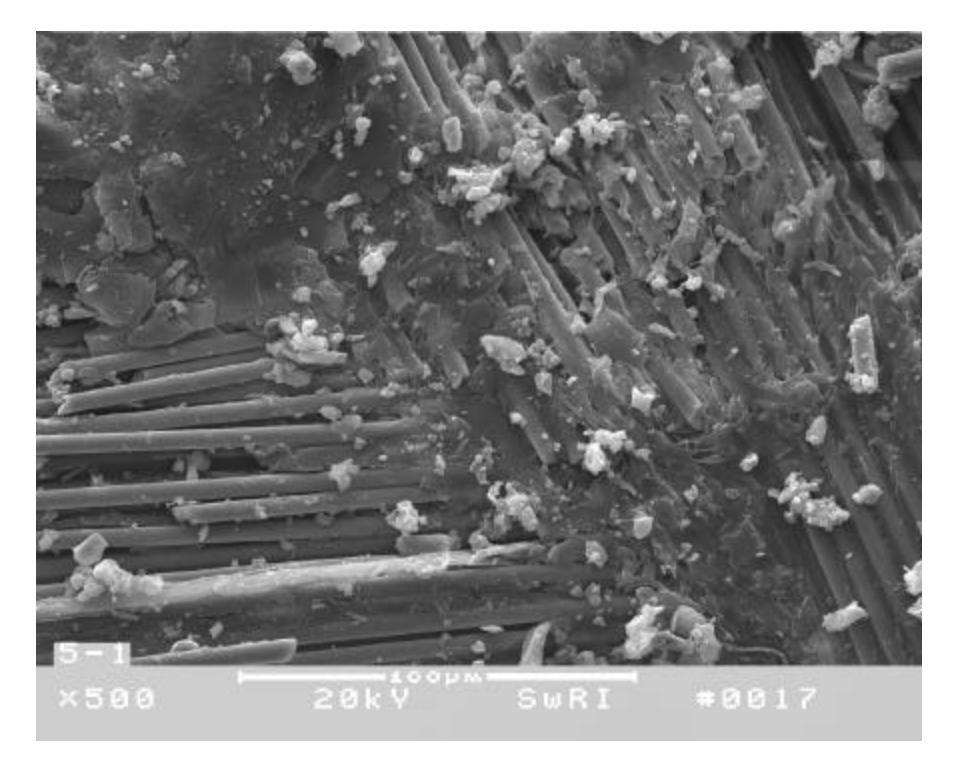
Sample 5-1 had the same number of coating layers as Sample 4-2, but was stripped to the bare fiberglass using acrylic media. As seen at 25X and 50X (Figures 21 and 22), the weave of the fiberglass is apparent, there is less resin on the surface, and there is more pitting compared to what was seen with Sample 4-2. Examination of the surface at 200X and 500X (Figures 23 and 24) reveals that almost two-thirds of the fibers are exposed. Although it is unknown whether the media or in-service usage caused the broken fibers, the acrylic media is more damaging to the fiberglass surface than the aluminum oxide media.

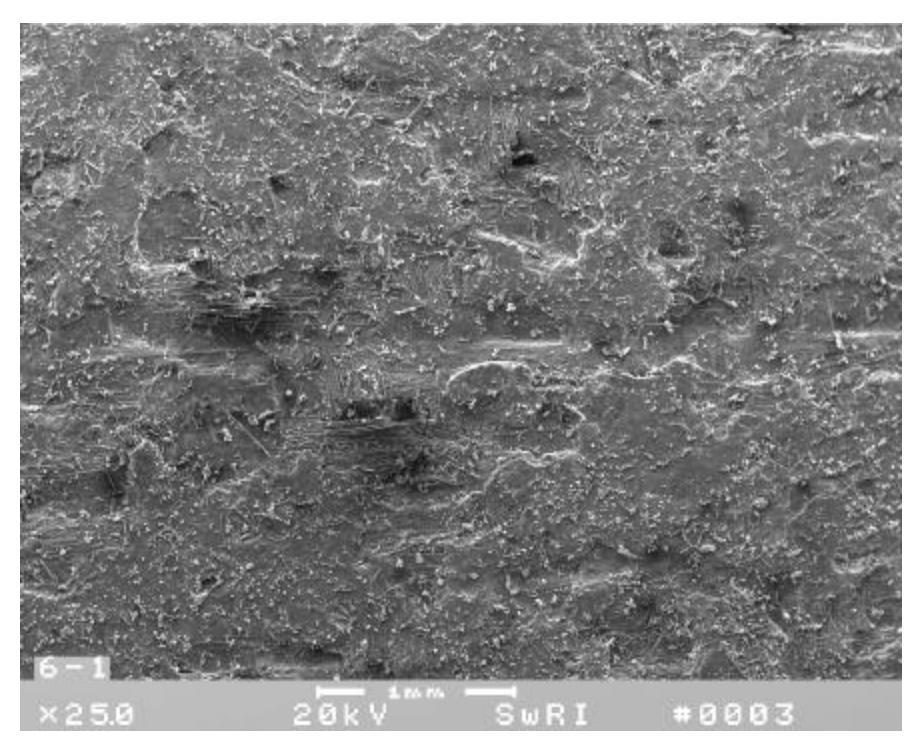
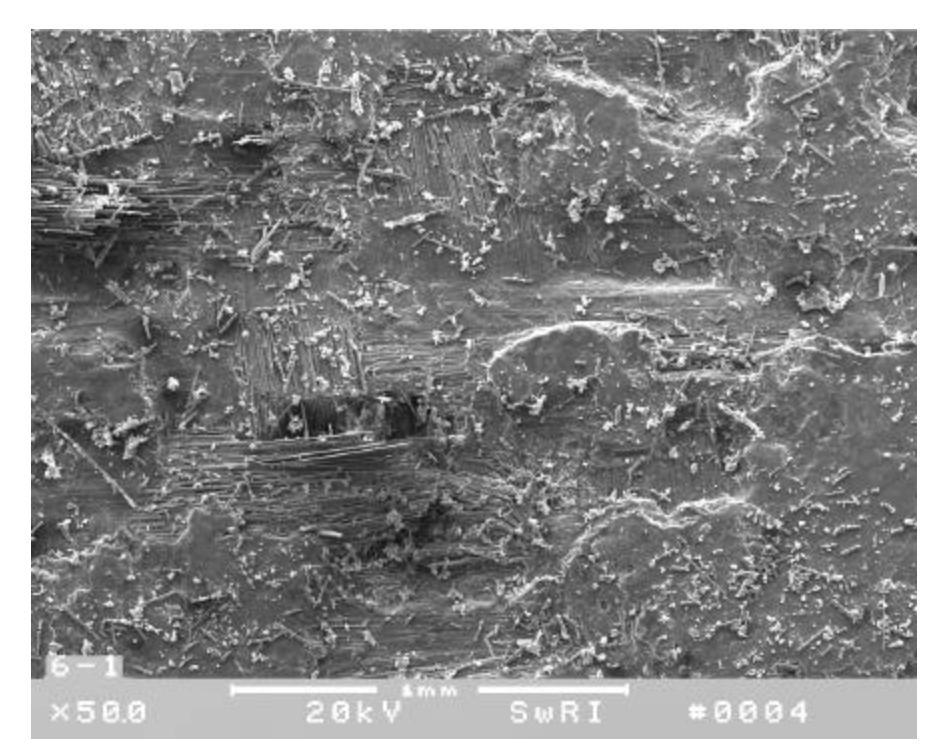
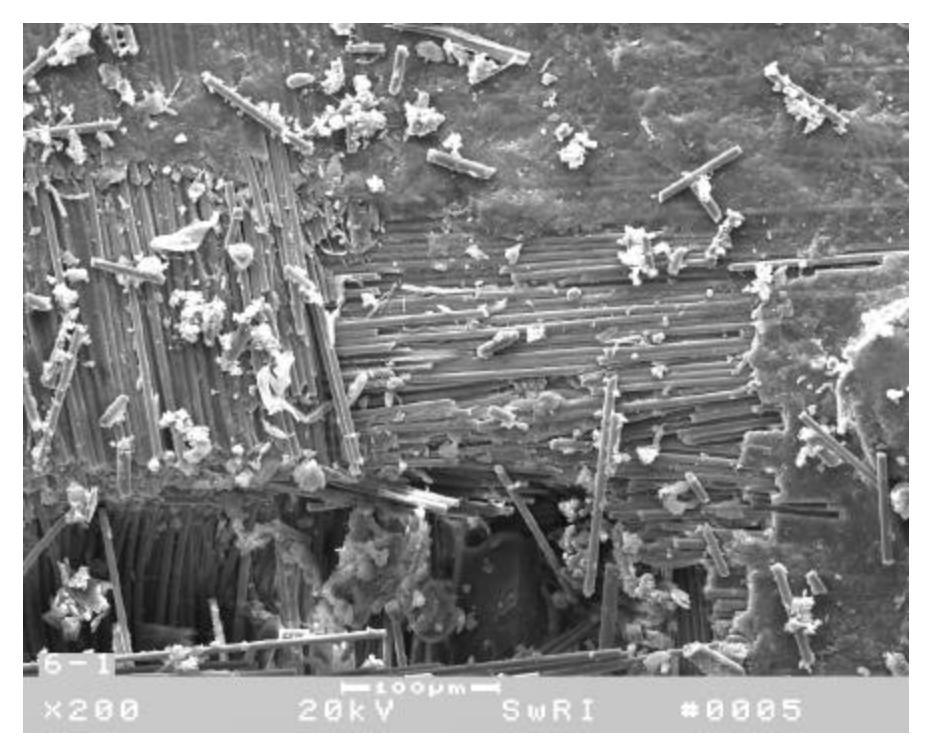
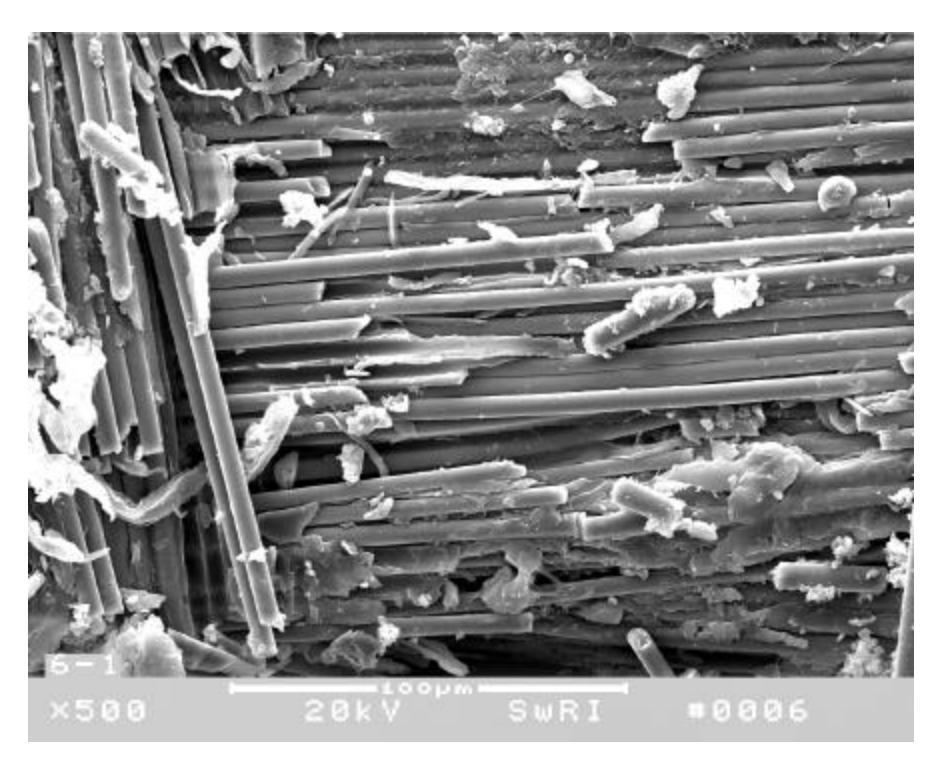
Sample 6-1 had the black erosion coating selectively stripped, leaving only the red primer. As seen at 25X and 50X (Figures 25 and 26), areas of the coating are still present. Fibers are exposed in some areas. At 200X and 500X (Figures 27 and 28), it is seen that the fibers are broken in bundles in both directions. It appears from these micrographs that the fiberglass surface may be sensitive to the acrylic process, meaning that the potential for damage caused by the acrylic media may vary between locations and operator error.
