Pliant Sponge Media[™] Abrasives and the Aerospace Industry:

Rain Erosion Coating Removal Utilizing Sponge Media[™] Abrasives

Barry S. Spigel, MS, Southwest Research Institute San Antonio, TX

Paper and Presentation at the 2000 DOD / Industry Aerospace Coatings Conference Norfolk Waterside Marriott, Norfolk, VA November 22-25, 2000

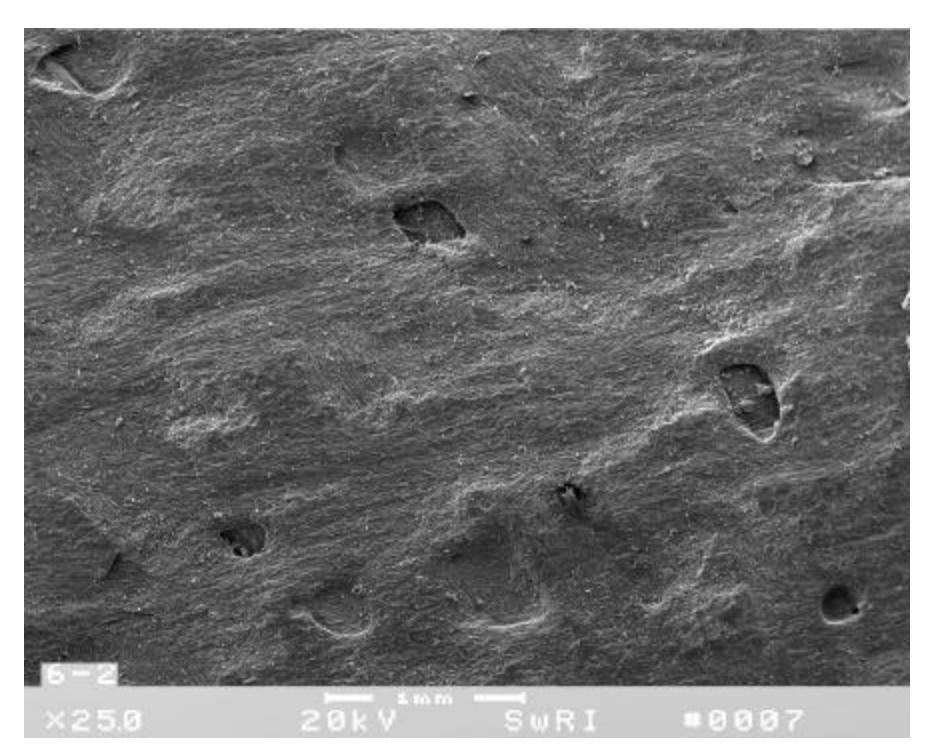
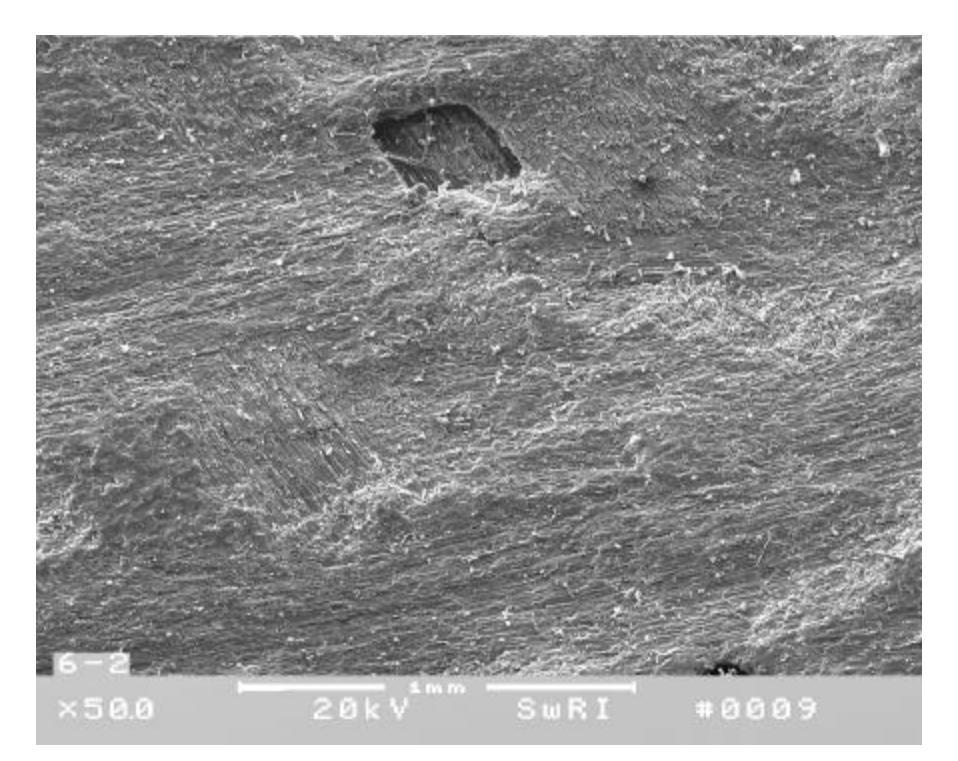
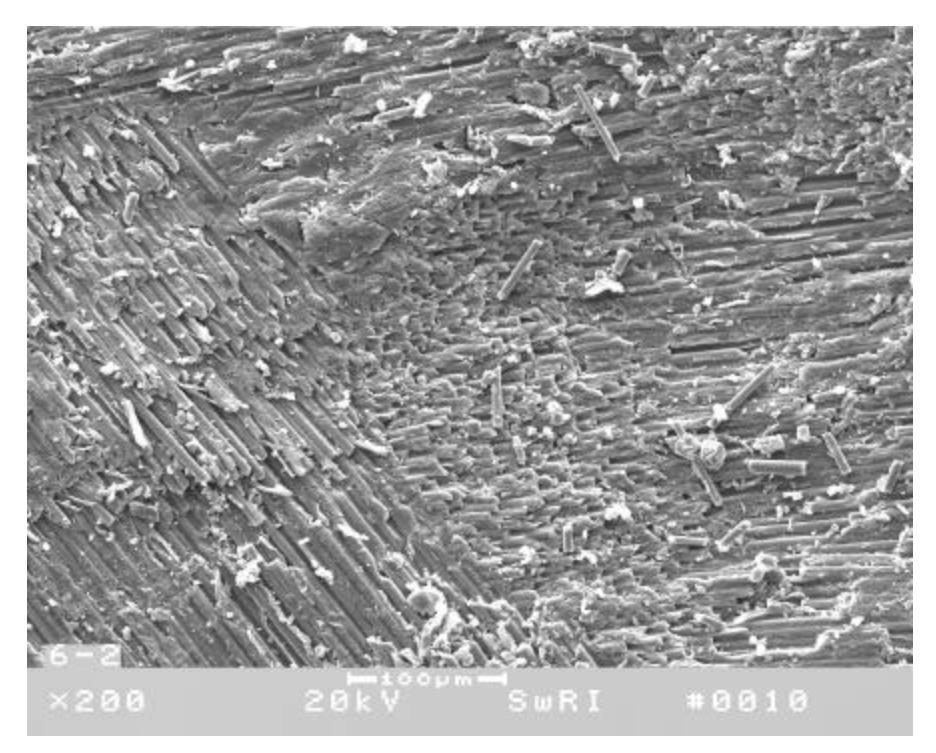
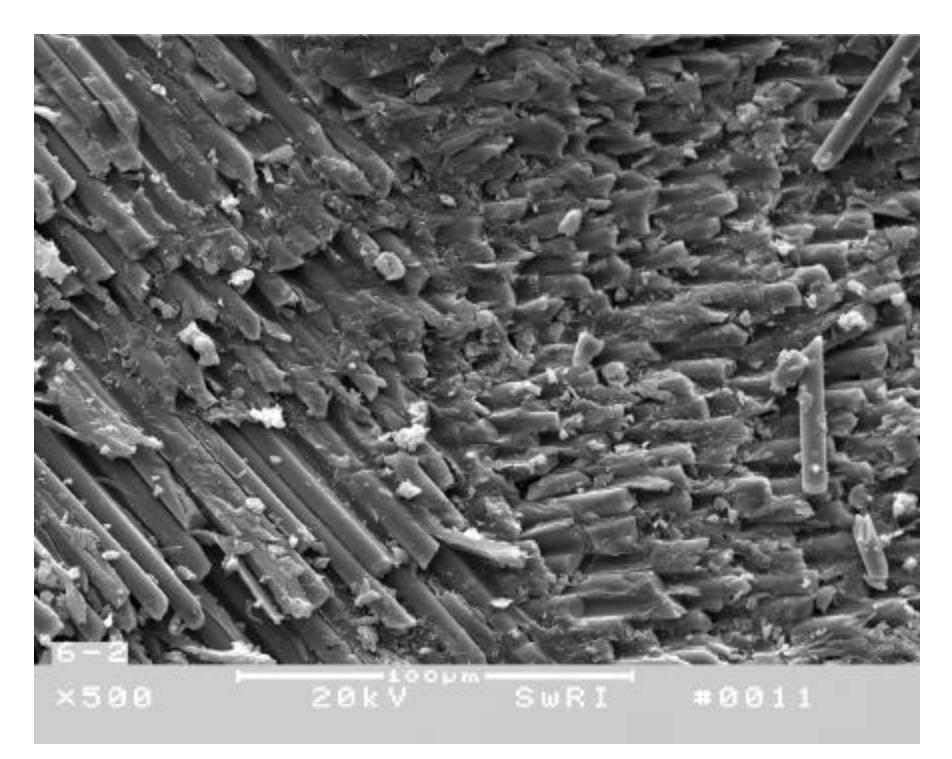
Figures 29 and 30 show the surface of Sample 6-2. This sample was stripped to the bare fiberglass, and pitting of the surface is seen. More importantly, at 50X (Figure 30), the fibers are exposed and there is very little resin remaining on the surface. This is seen at 200X and 500X (Figures 31 and 32). As compared to Sample 4-2, the number of exposed fibers is clearly greater. This comparison indicates that the acrylic media is more damaging to the surface of the fiberglass than the aluminum oxide media. Service history may have caused the pitting and some

of the broken fibers, but the extent of the fiber's exposure on the surface likely resulted from the acrylic media.
