## Crown of Gold: Roof Gleams Anew Atop N.Y. Landmark

From *D+D*, September 2010

New York Life summoned The Gilders' Studio Inc., based in Olney, Md., to formulate and execute a restoration and regilding program for the pyramidal, lantern-topped roof, composed of 25,000 gilded tiles. The job entailed an in-depth evaluation of materials and methods to return the roof and lantern to their former, glittering appearance. The company also serves as construction manager for the project.

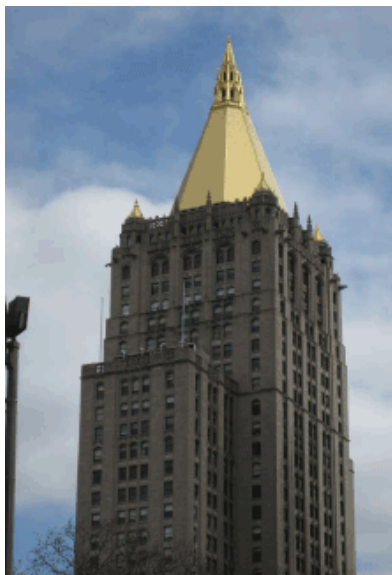
*The upper section of the building, showing the gilded roof following restoration*

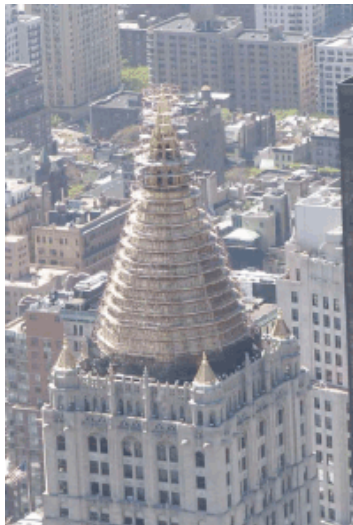
*Atlantic Hoisting and Scaffolding erected 23 levels of scaffolding for the project.*

Application of the two-component primer—MACROPOXY 646 from The Sherwin-Williams Company—was done by the painting subcontractor, Caruso Painting and Decorating Corp. of New York. Scaffolding—a monumental job in itself, with 23 levels needed from the base of the roof to the top of the lantern—was erected over a six-week period in early 2007 by Atlantic Hoisting and Scaffolding, Brooklyn, N.Y. Application of size and gilding was the work of The Gilders’ Studio, using a slow oil size from Rolco Labs, Carlstadt, N.J. The gilding was done with 23.75-karat leaf from Italy.

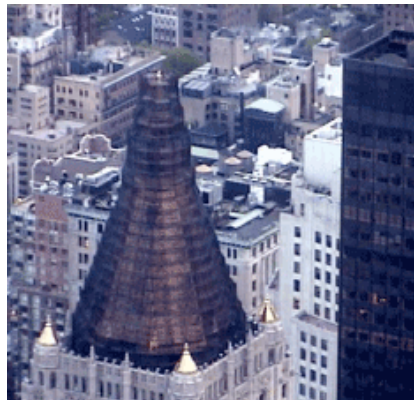
*The roof and lantern, shown shrouded in mesh during coatings-removal process.*

Kramer said a sponge-type media proved to be a good choice for the job of coatings removal, as it scoured the surface and absorbed any dust generated by the loosening of the existing coating. In the process, the media is recycled and reused multiple times with a vacuum and sorting system supplied by Sponge-Jet Inc., Portsmouth, N.H.

The media type used was Sponge-Jet’s Silver Sponge, a composite of aluminum oxide and urethane sponge. The media is offered in a range of aluminum-oxide grit sizes, with the grade determined by the profile specified for the job. The profile range is from 6 microns (less than .25 mil) to approximately 100 micron (appr. 4 mil).

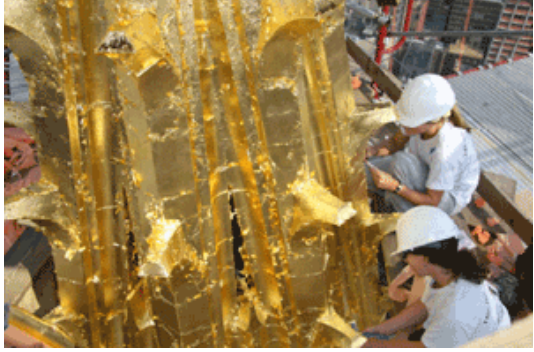
*Gilding in progress.*

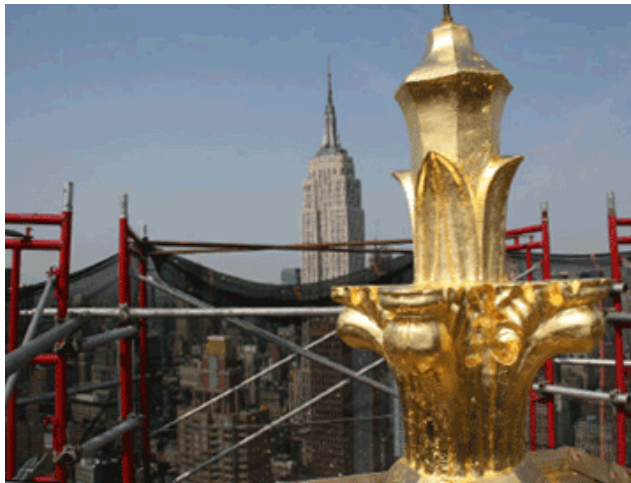
*An ornamental finial following gilding; in the background is the Empire State Building.*
