#### Project 857

- Queensland Rail, Maintenance Division for rolling stock
- Maintenance Division conducts repairs on many types of electric passenger trains; from old style to high-speed trains
- Of many repairs, pantograph bases represent the most frequent and timely for repairs

• Explore opportunity to reduce repair time, while maintaining specification and quality standards

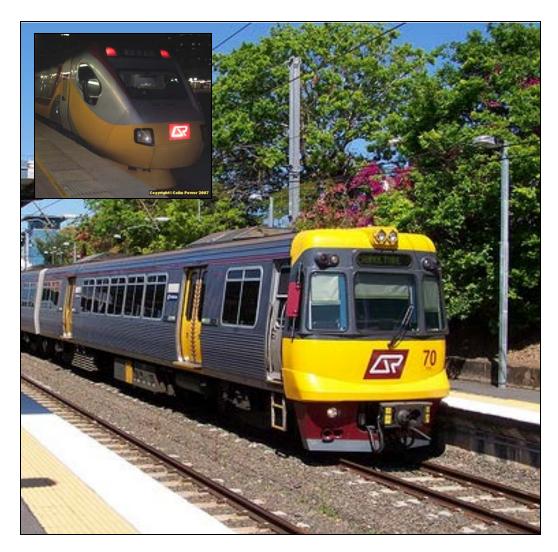
### Substrate: Stainless steel

Size: 6.2m<sup>2</sup> (67ft<sup>2</sup>) per unit

# **Surface Condition:** Ceramic (insulating) coating; 1.6mm thick

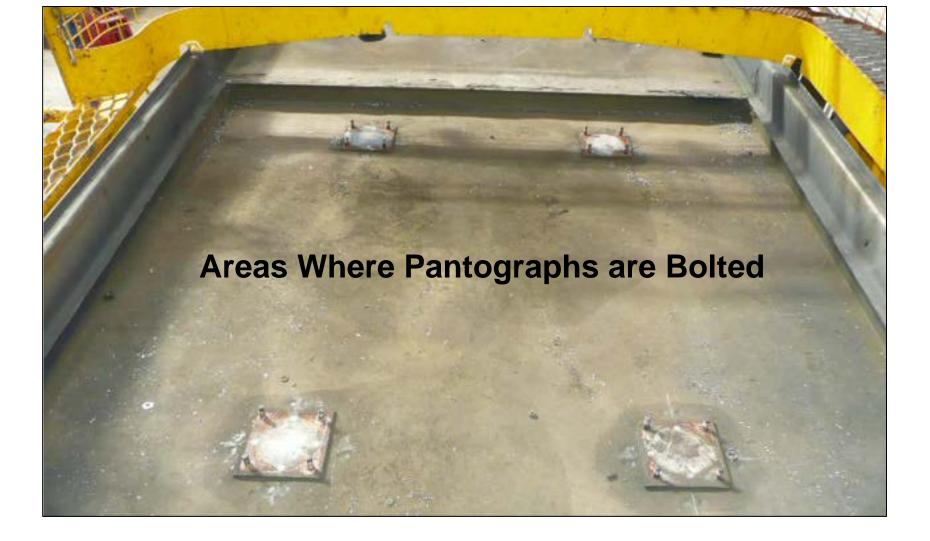
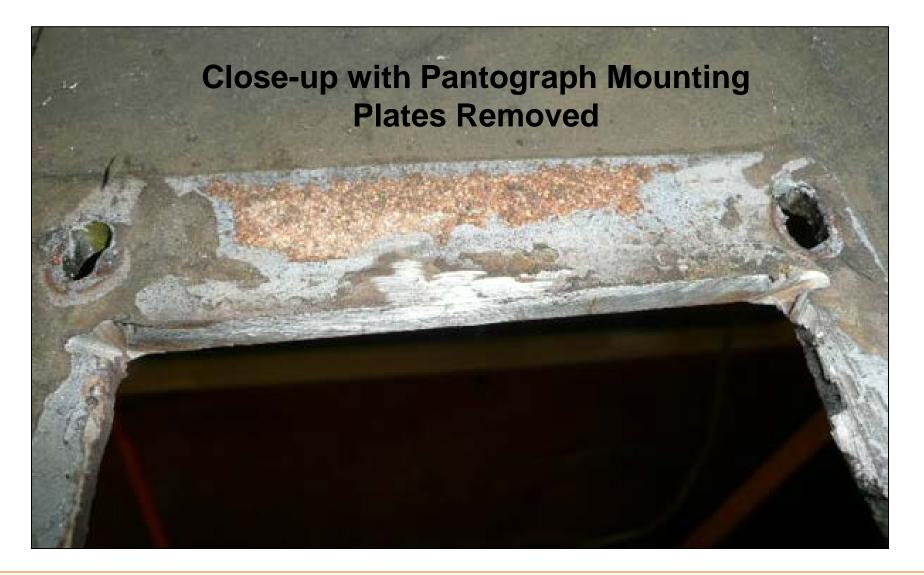
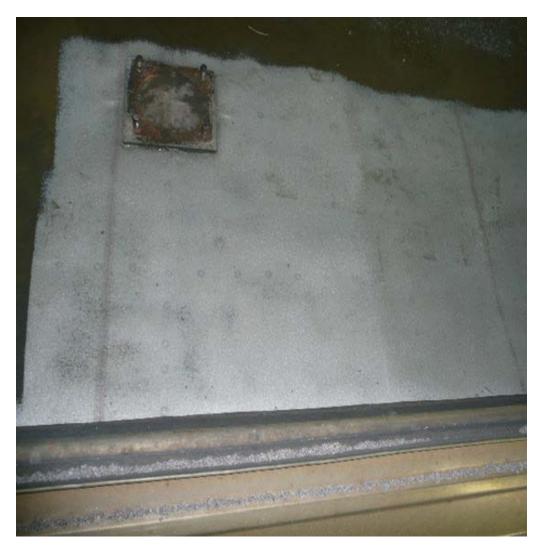
**Used:** Silver 60 Sponge Media<sup>™</sup> abrasive, 100-HP Feed Unit<sup>™</sup> and 35-P Sponge-Jet Recycler<sup>™</sup>

Near White Metal Blast Cleaning NACE 2 / SSPC SP-10 / Sa2.5

## **Production Speed:** Profiled 1.5m<sup>2</sup> (16ft<sup>2</sup>) in five minutes
