# Soft-sponge Abrasive Helps Presidio Get Tough on Graffiti

*by Jack Innis*

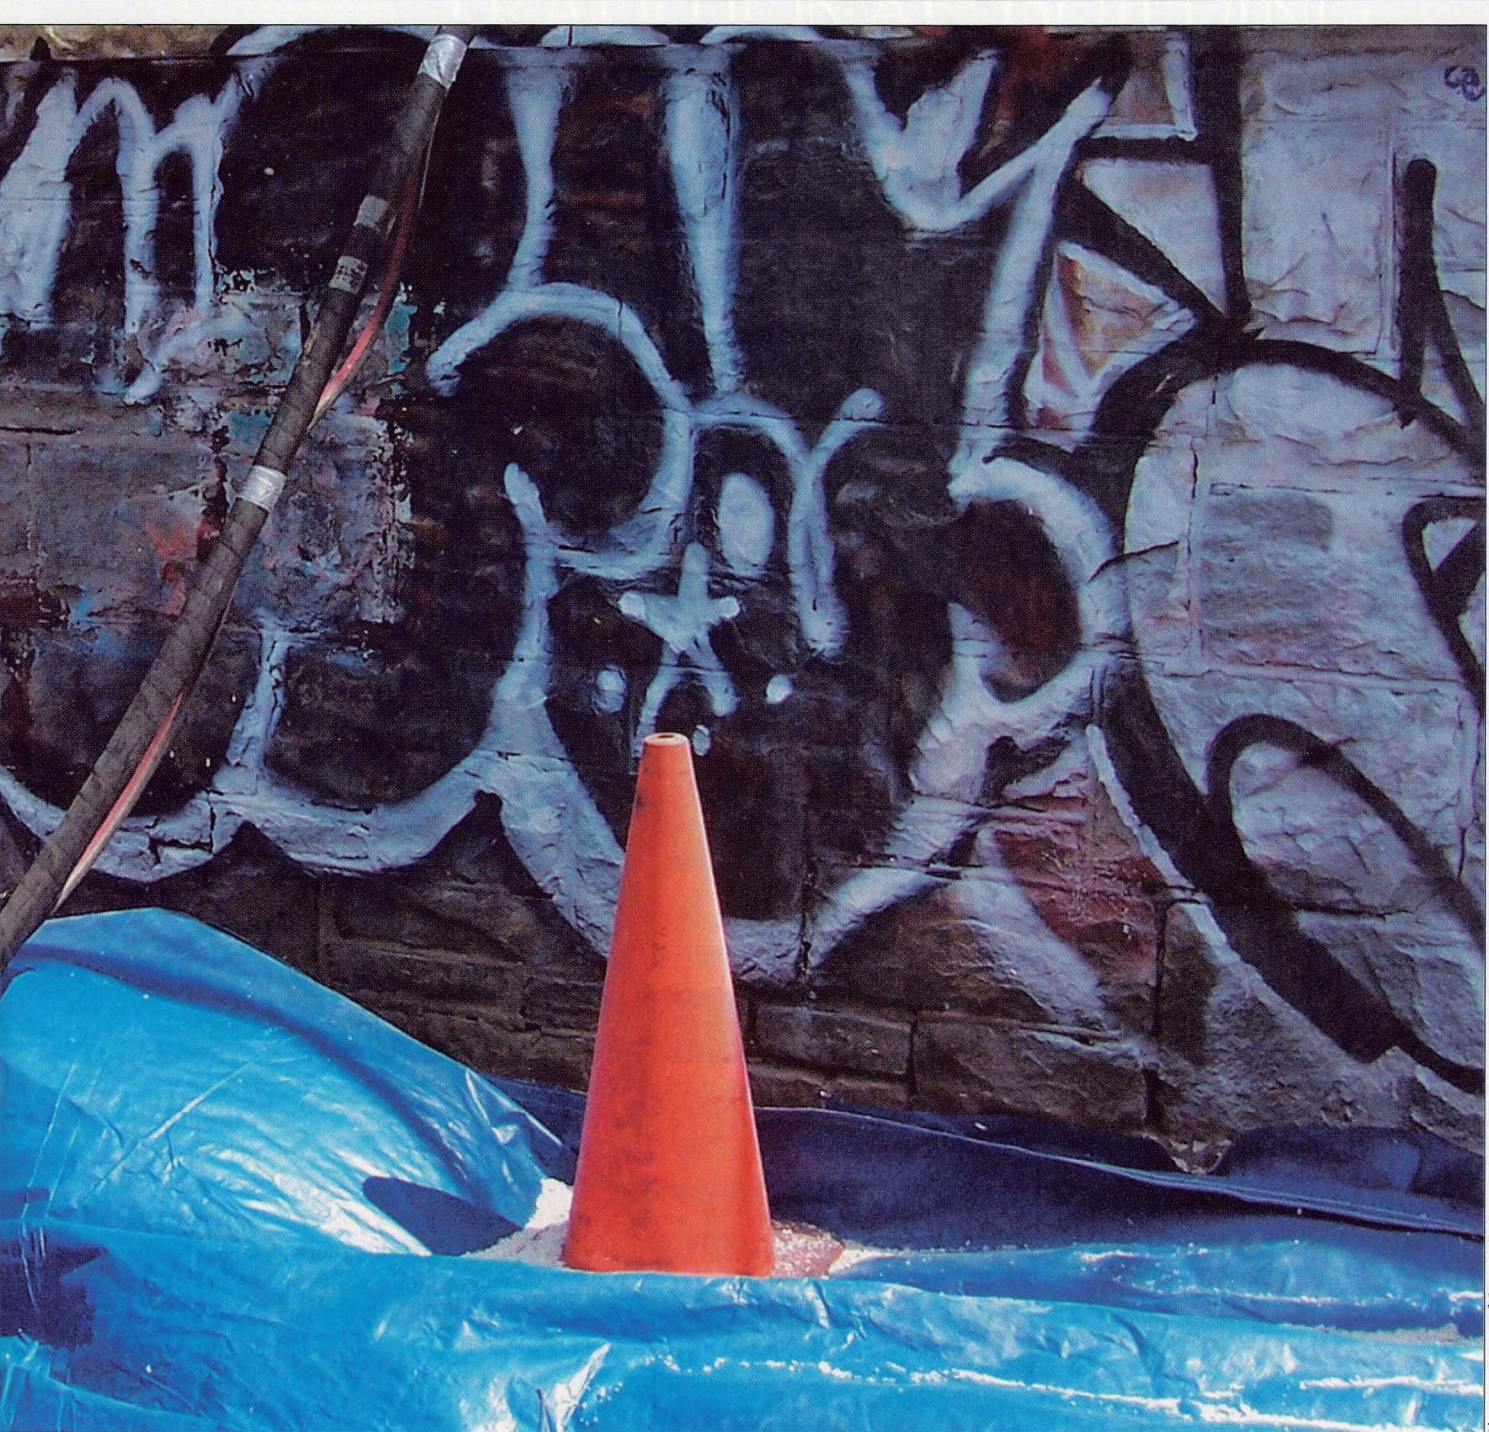
Since 1994, the Presidio has been a part of the Golden Gate National Recreation Area. Among the park's most enduring features is the Presidio Boundary Wall, a five-mile-long, broken-range, ashlar-pattern sandstone wall along the Presidio's south and east perimeter

that was built in 1896 and is now a National Historic Landmark.

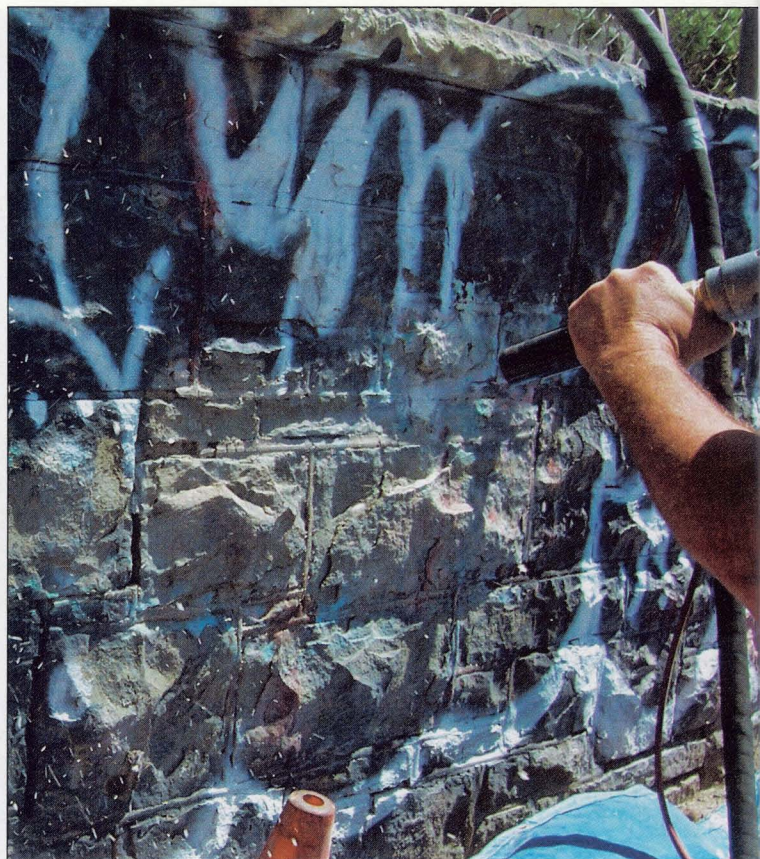
Cleaning systems involving mild mechanical abrasive action were tested, including hot and cold pressurized water, micro-abrasives, the JOS Cleaning System from Stonehealth, and Sponge-Jet's Sponge Blasting System. Among mechanical frontrunners, the JOS system uses a rotational vortex to increase surface action while reducing the pressures of air and water and the volume of abrasive. The Sponge-Jet system uses variable air pressure to propel water-based polyurethane foam particles, which are impregnated with a cleaning agent. The pliant foam media flattens upon impact, exposing the cleaning agent or abrasive. The sponge component is softer than other abrasives and provides less of a hard edge upon impact on surfaces. Sponge-Jet's system allows opera-

tors to control the aggressiveness of their removal to protect sensitive substrates.

The Sponge-Jet system was selected for future graffiti removal along the Presidio Boundary Wall. The media that worked best was the sponge impregnated with spherical precipitates of calcium carbonate, which removed paint very gradually and in a very controlled manner. Among advantages listed were minimal sandstone surface disruption with the exception of some minor spalling of already-loose stone and mortar. The system uses no volatile organic compounds (VOCs) or other hazardous chemicals, is environmentally friendly, is easy to clean up, and requires no water or rinsing. Adjustable air pressures allow lower levels to reduce spalling. In addition, the Sponge-Jet equipment has an observer-operated cut-off switch for added control. Although initial set-up may involve a capital expense or rental fee, Sponge-Jet's blast medium is reusable, thus lowering overall costs.
