An Unexpected Challenge Leads to a HIGH-TECH SOLUTION

BY DREW JOHNSON, CORROSION CONTROL RESOURCES, INC.

The coating contractor was brought on by the project's general contractor to perform removal of the existing internal lining of a 60-inch (1.5 m) raw water line. Once the liner was removed, the crew was tasked with relining the pipe. Limits of the liner removal and relining were defined as inside the pump station to outside the pump station where the aerial (aboveground) pipe transitioned below grade.

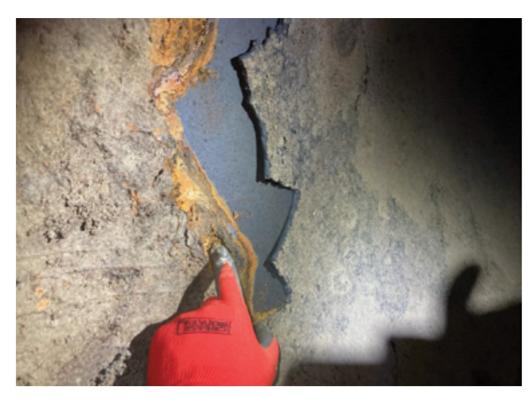
FIG. 2: The crew had their work cut out for them as the coal-tar enamel had failed in areas, leaving behind corrosion in the 60-inch raw water pipe.

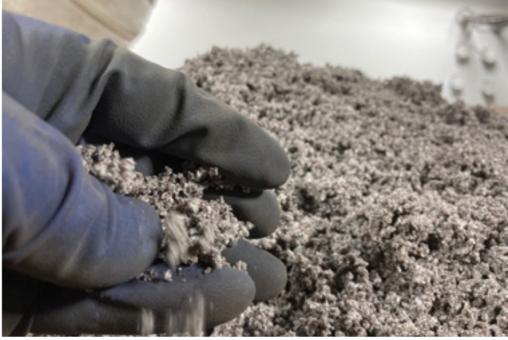
FIG. 3: Given the surface area, the total coal slag abrasive media (top) required for this job was estimated to be 21 to 22 semi-trucks filled with abrasive media. After test blasting determined that 100 lbs. of coal slag removed just under 1 square foot of coal-tar enamel, it was apparent that sponge media (bottom), along with robotic abrasive blasting, was the only viable option.

To prove that ordinary grit was not the right choice given the newly discovered coal-tar enamel lining, the crew performed a test blast using ordinary blasting equipment and coal slag abrasive on a section of the pipe. Results of the test blast showed that 100 lbs. (45 kgs) of media removed just under 1 ft 2 (0.1 m 2) of coal-tar enamel. Given the surface area of 3,500 ft 2 (325 m 2), the total media required with minimal waste would be 350,000 lbs. (160,000 kgs) – or about 21 or 22 semi-trucks filled with abrasive media.

After the test blast, the engineers on the project determined that sponge media, along with robotic abrasive blasting equipment, would the most viable option to save the job and keep the contractor's schedule on track.

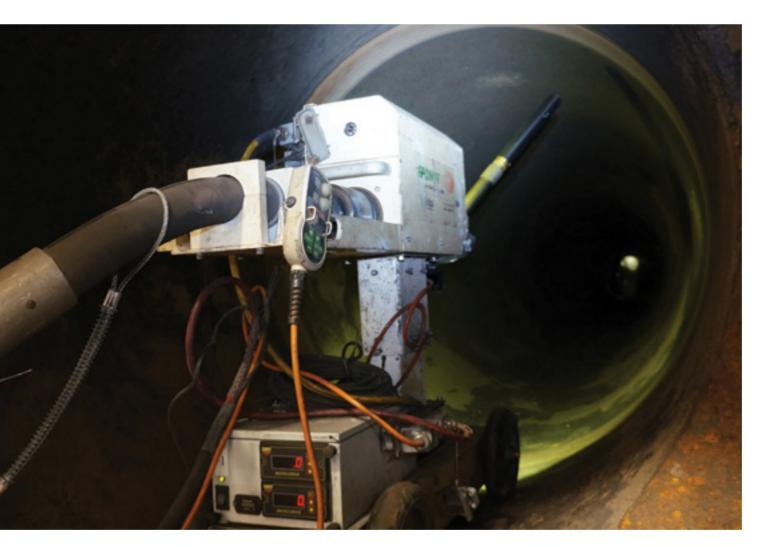
FIG. 4: Robotic abrasive blasting was a safer option for the crew, allowing for reduced man hours spent in the confined space of the pipe.

The speed of coal-tar enamel removal varied based on the thickness of the coal-tar enamel. The robot speed varied, but ran most of the time at 2.2 inches (6 cm) per minute.

With the 60-inch diameter pipe, that equates to $2.87~\rm{ft^2}$ ($.25m^2$) per minute. To compare, it took two minutes and 32 seconds to remove under 1 ft² ($.1m^2$) of liner when hand-blasting with coal slag. Even when accounting for the robot having two nozzles, it is still safe to say that using this method was approximately three-to-four times as fast as conventional hand blasting.

In addition to saving time and money, the robotic system provided a safer way to remove the coal-tar enamel lining from the interior of the pipe. If the contractors had attempted to use hand blasting with coal slag, the crew would not only have been blasting in a confined space, but they would have also had to carry the 350,000 lbs. (160,000 kgs) of abrasive media out of the pipe, bucket by bucket. With robotic abrasive blasting, the man-hours the crew spent in the confined space of the pipe was significantly reduced, making the jobsite much safer. The robot was operated from a pendant, which allowed operators to remotely adjust drive speed, direction and blast arm rotation. However, because of the hazardous nature of the existing lining, the team wore special protective suits, extra-heavy chemical gloves and utilized protective breathing gear when in any type of contact with the coal tar enamel. The same PPE was used later on in the project when they began the coating application process.

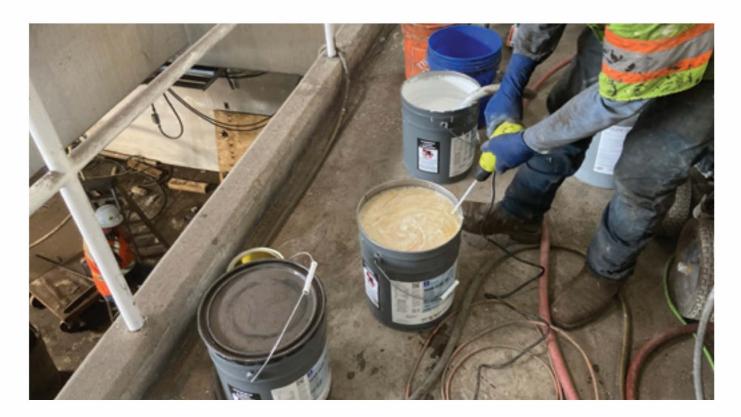
FIG. 6: Using spray application equipment, the crew applied three coats of an 80%-solids epoxy coating specially designed for application in pipes and tanks containing potable water, wastewater and salt water, in contrasting colors (white, blue and white) at dry film thickness of 7 mils per layer. In between the first white coat and the blue coat, the crew applied a stripe coat to all edges, welds and transition areas.

Using heavy-duty pneumatic airless spray equipment, the crew applied three coats of the coating in contrasting colors (white, blue and white) at a DFT of 7 mils per layer. In between the first white coat and the blue coat, the crew applied a stripe coat to all edges, welds and transition areas. Special termination was made in some areas using a 100%-solids epoxy surfacing compound designed as a fairing compound for weld seams and riveted connections. The crew also sealed the areas where the pipe was mechanically joined together internally
