NO DUST NO PROBLEM

Saving Time and Money on Concrete Sludge Tank Rehab Project

BY JIM MARSTON, MARSTON INDUSTRIAL SERVICES

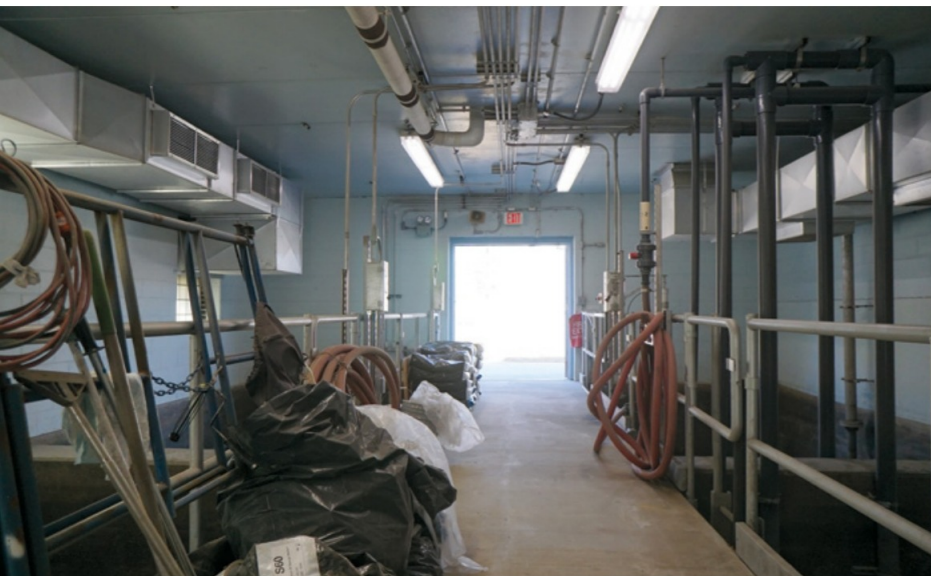
FIG. 1: Wastewater treatment facilities house not only sludge tanks, but also complex piping, ventilation, electrical conduit and access systems. Abrasive blasting using sponge media created very little ricochet, allowing the contractors to simply cover all equipment with reinforced poly.

The sponge abrasive also created very little ricochet during the blast process. With traditional abrasive blasting, the crew would have had to wrap all the surrounding piping and equipment in rubber to protect them from the ricochet. Instead, they just had to cover the piping with reinforced poly. This was a much easier and a less labor-intensive process for the crew.

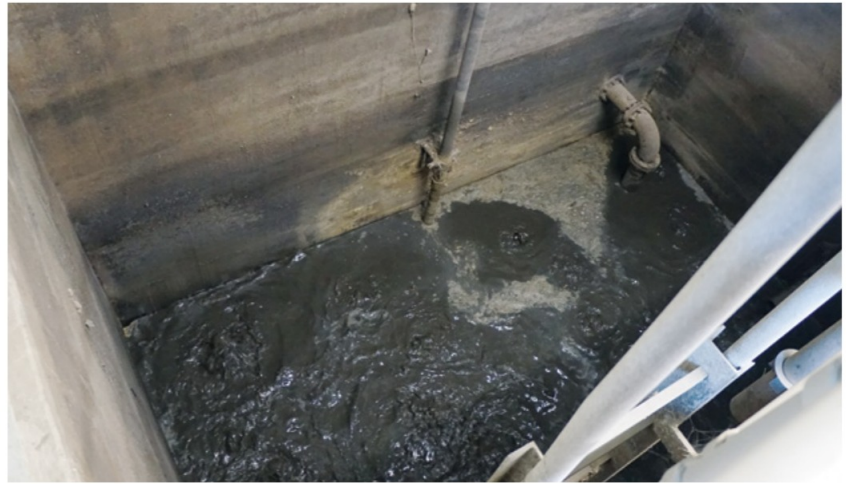
FIG. 2: The Kennebunk Sewer District meets the sanitary sewer needs of all residents and visitors to the town. Wastewater is received and treated at a secondary treatment facility that houses the three below grade concrete sludge tanks.

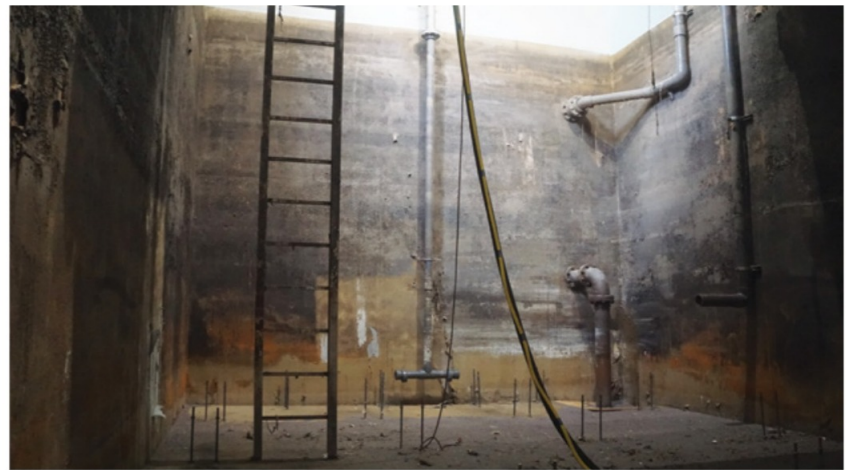
FIG. 3: Each sludge tank is 2,000 square feet in area, and all three were in need of rehabilitation. The crew worked on one tank at a time, completing all coating removal, abrasive blasting and coating application before returning it to service and starting on the next tank. The two tanks not being worked on remained fully operational.

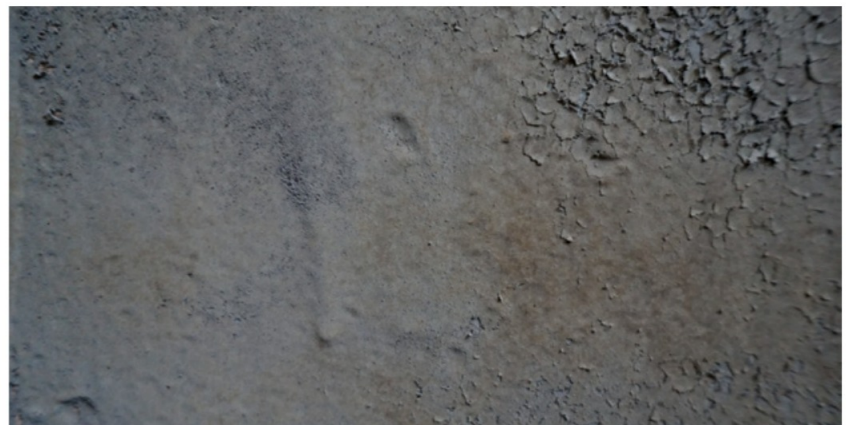
FIG. 4: The existing coating in tanks was a thick, rubberized coating that was failing and delaminating in many areas. The challenge for the crew was completely removing the failed coating and not damaging the concrete substrate underneath.

A condition assessment found that the existing thick, rubberized coating was failing and delaminating in many areas throughout the tanks' interiors. The crew was tasked with removing the existing coating without damaging the concrete underneath. The last thing they wanted to do was create more issues by damaging the substrate and then having to repair those damaged areas, especially since they needed to stay on schedule and within budget.

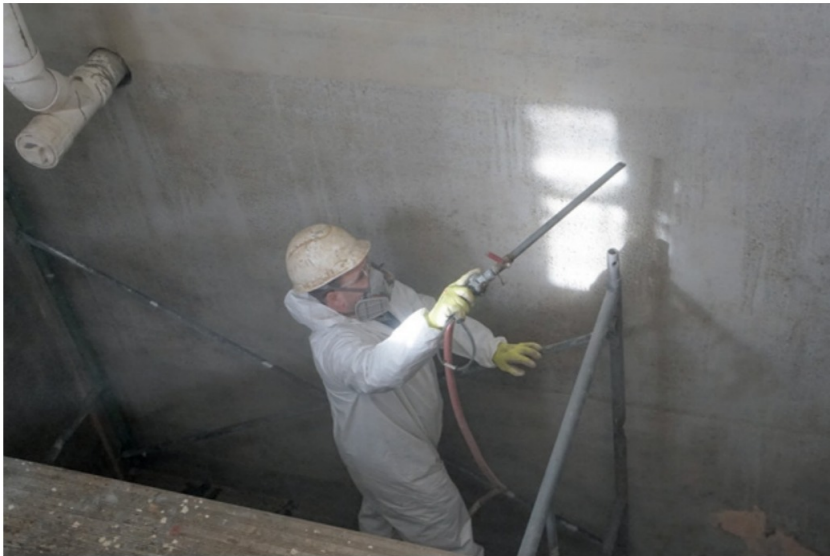
FIG. 5: Once the sponge media abrasive blasting was completed, the crew blew down and vacuumed the tank's interior to rid the surface of any debris. This was the final step prior to the coating application.

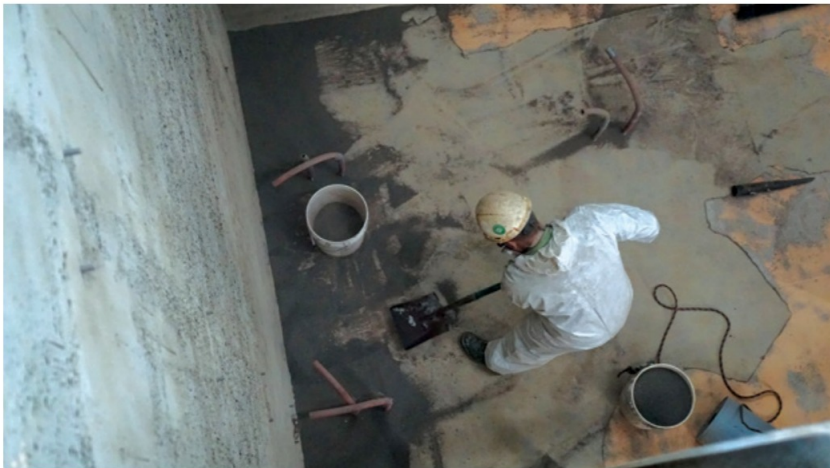
FIG. 6: Only 17 30-pound bags of the sponge media were used per tank. With conventional abrasives, the disposal process would have been time-consuming and expensive, especially considering the tanks are 15 feet below grade.

abrasive media, the sponge media used on this project is recyclable. The crew originally looked into using a different type of non-toxic media, but quickly realized that that single-use abrasive would create cleanup issues. If they had gone with the original plan to blast with ordinary abrasives, they would have used 8,000 pounds for each of the 2,000-square-foot concrete tanks, compared to only 17 30-pound bags of sponge media per tank. With ordinary abrasives, the crew would have needed to bring in vacuum trucks, and the disposal process would have been more time-consuming and costly, especially considering the tanks are 15-feet below grade. With the recyclability of the blast media, cleanup was relatively easy and not labor intensive.

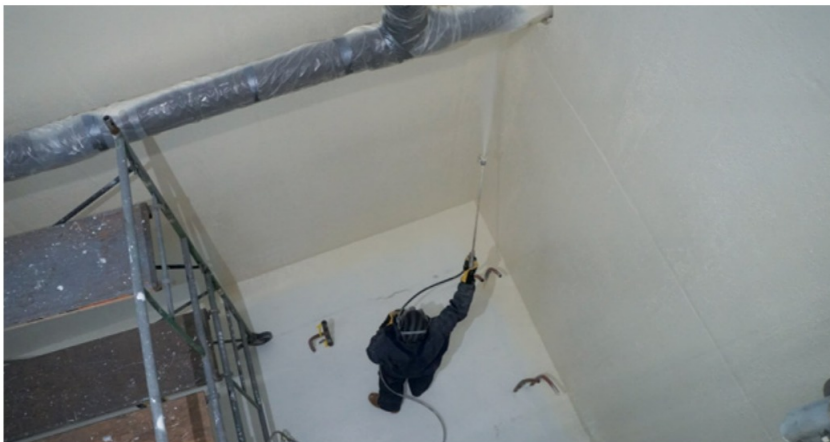
FIG. 7: The coating system consisted of an epoxy primer coat and polyamide epoxy topcoat, applied using airless, plural-component spray equipment.

Once the old coating system was completely removed from the interior of the tank, the concrete was properly profiled and all debris was removed, the crew was ready to begin applying the new protective coating system. They started with a primer coat of a polyamide epoxy mastic at a thickness of 6-8 mils using airless spray equipment. This fast-cure mastic is a high-solids, high-build epoxy designed to protect concrete in industrial exposures, such as wastewater treatment facilities.

For the topcoat, the team installed a two-component, 100% solids, elastomeric, aromatic polyurethane. For this coating application, the crew members used a plural-component spray unit to lay down 100-125 mils over three passes.

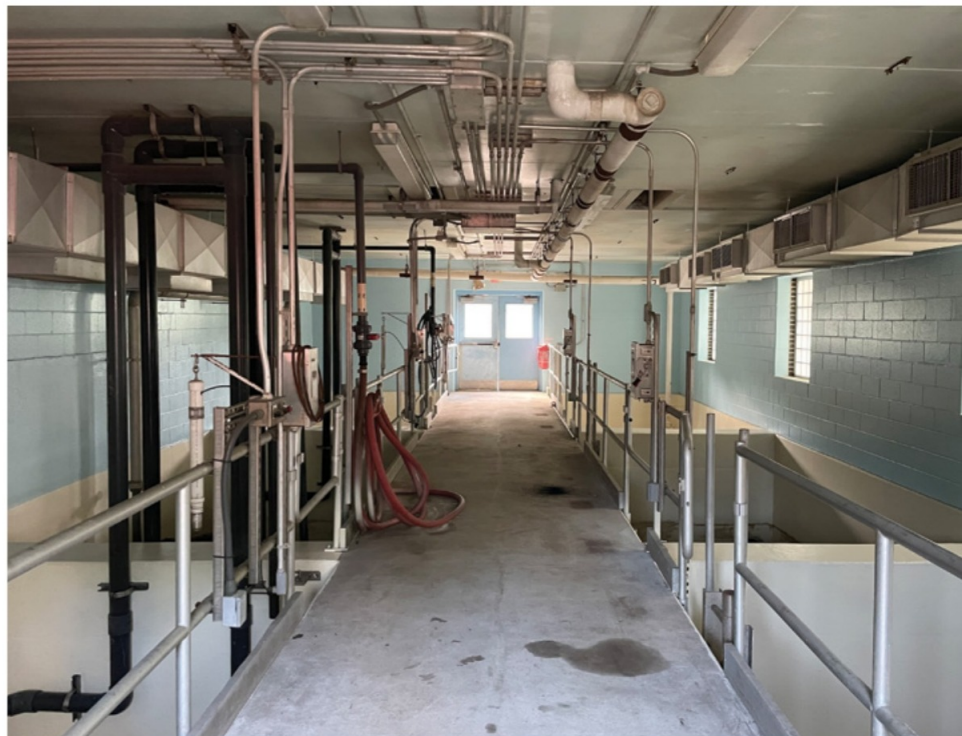
FIG. 8: With all three tanks completed, the Kennebunk Sewer District wastewater treatment facility is back up and running at full capacity.

From start to finish, the rehabilitation of all three tanks took two months, with each tank requiring an equal amount of time. The coating removal and abrasive blasting process took about seven to eight days per tank, and the coating application took the crew about four days per tank. As far as sequencing goes, the crew would drain one tank, remove the failing coating, prep and profile the surface, apply the new coating system, put the tank back into service and then start with the next one.

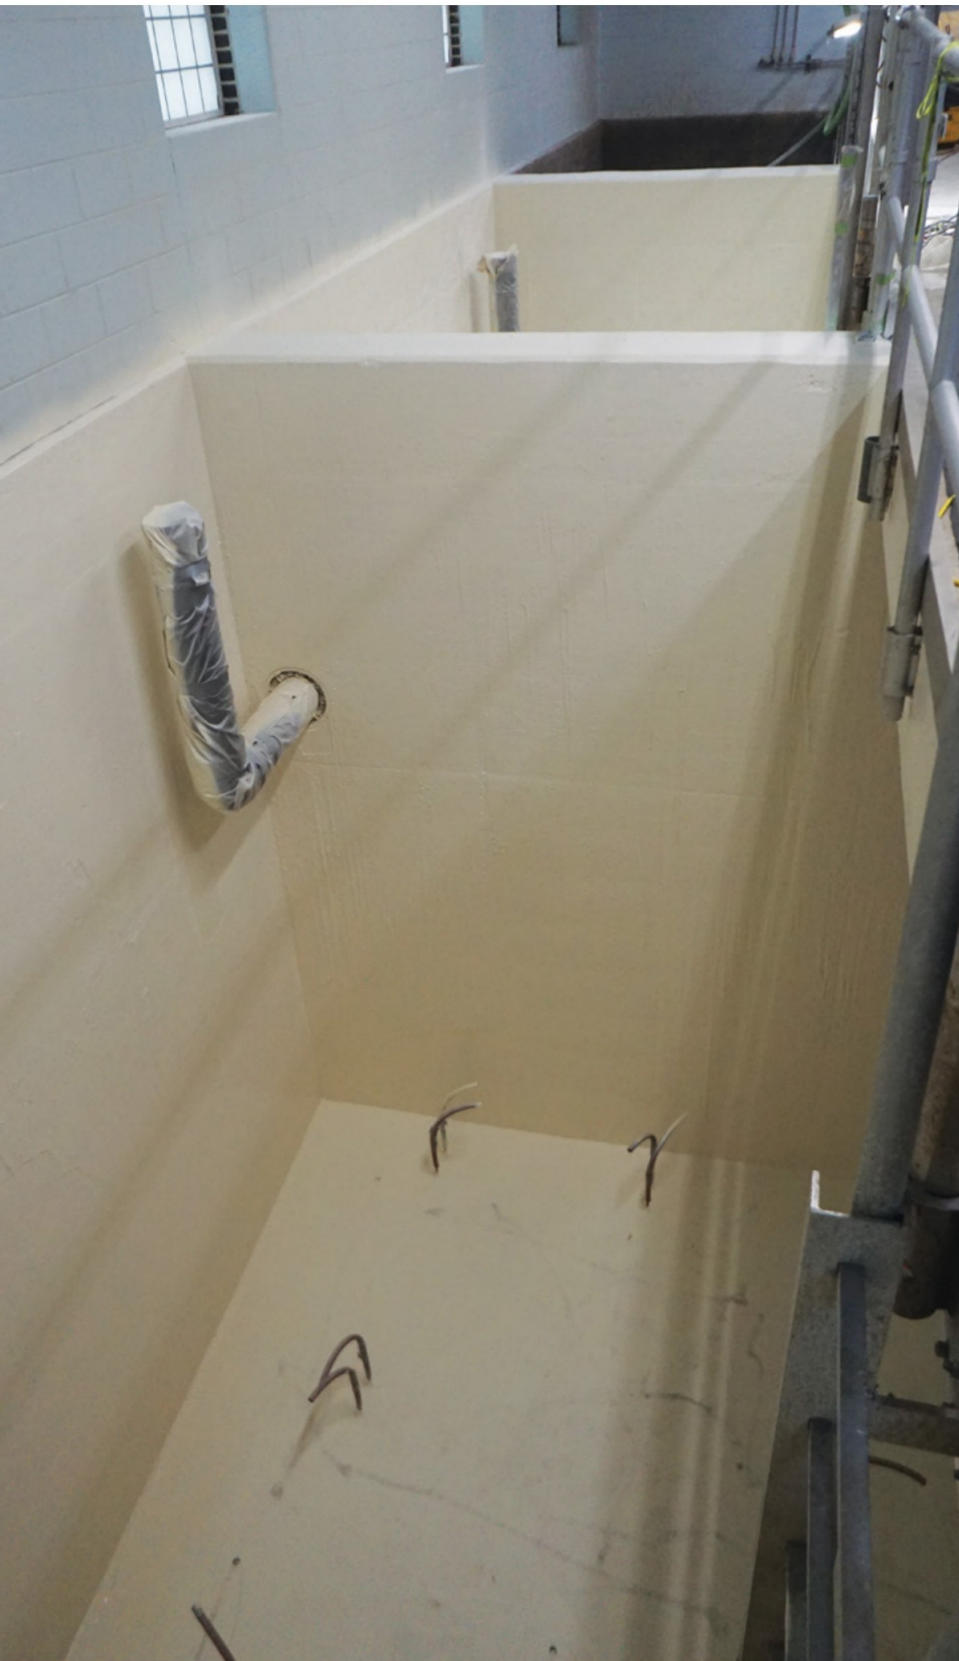
FIG. 9: The job was completed over a two-month timeframe, with each tank taking an equal number of days. The new protective coating system provides a long-term solution for the three sludge tanks.
