Case History

Surface Prep in Cotton Mill Brown Stock Washer Tanks

The Sponge-Jet[®] abrasive blasting system and Sponge Media[™] abrasives were used to strip caustic deposits and failed coating from Black Liquor Tank

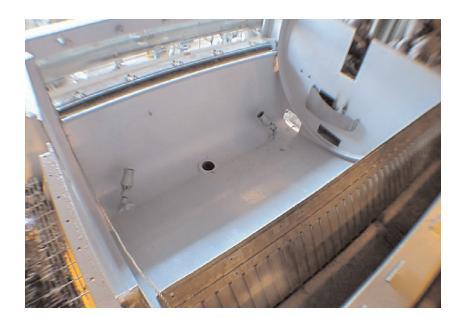
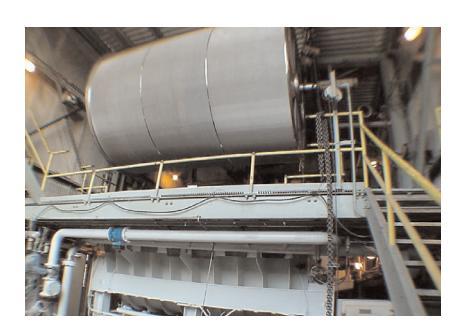
■ Fast Setup & Cleanup - Other trades continuing to work nearby, along with the critical time constraint, meant blast setup and cleanup had to be quick and easy. The low dust and rebound characteristics of Sponge Media abrasives allowed the tank to be easily covered and sealed for containment, which simplified cleanup.

IMS, Inc. blasted and coated the 65m² (700ft²) tank overnight. By blasting with Silver Sponge Media[™] abrasives in the purification tower with other trades working below uninterrupted, the plant remained "dust free." The project supervisor was thrilled with the quality and timeliness of the project.
