# Remove Paint, Corrosion and Profiling Structural Steel Bases in Amusement Park Play Facility

Project 856

- Remove paint, existing corrosion where necessary and profile the superstructure's steel bases, then re-coat

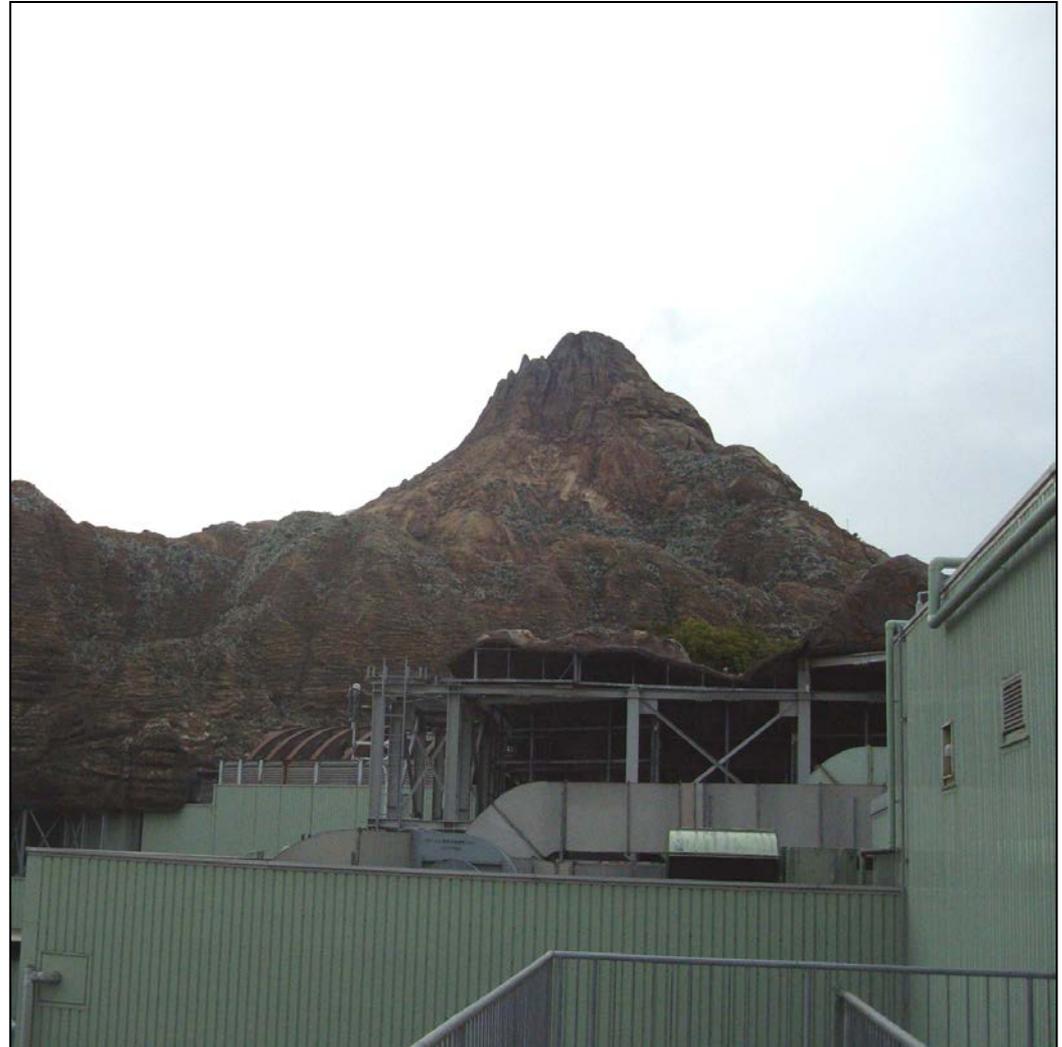
- Structural steel bases in park's play facility were corroding in dark, humid setting
- Coating failure in many areas
- Park operates 9am to 10pm, year-round
- Short window of opportunity for blasting and painting; allowed only during non-operating hours

**Surface Condition:** peeling paint;  
mid-grade rust on frame bases

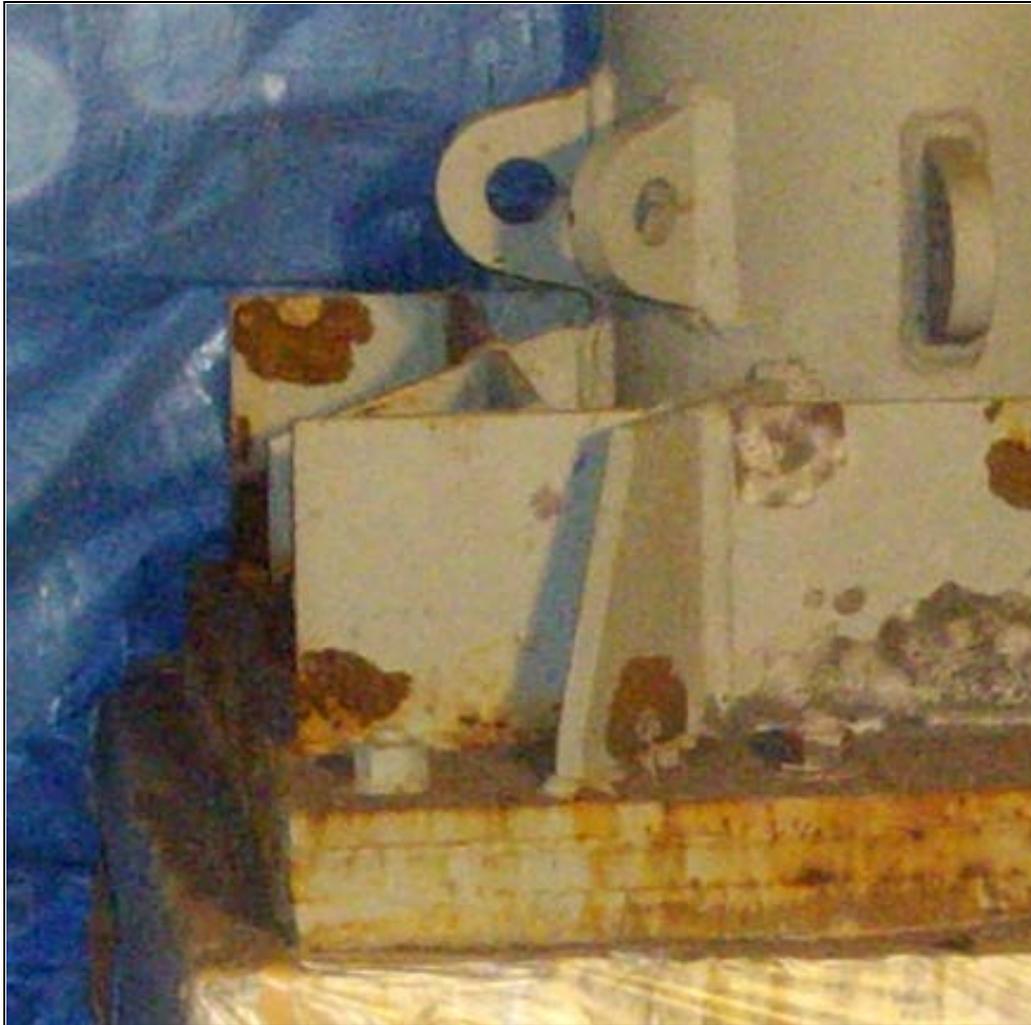
**Substrate:** steel

- Hand-tools; could not effectively remove rust and paint and effectively profile in confined locations (crevices)

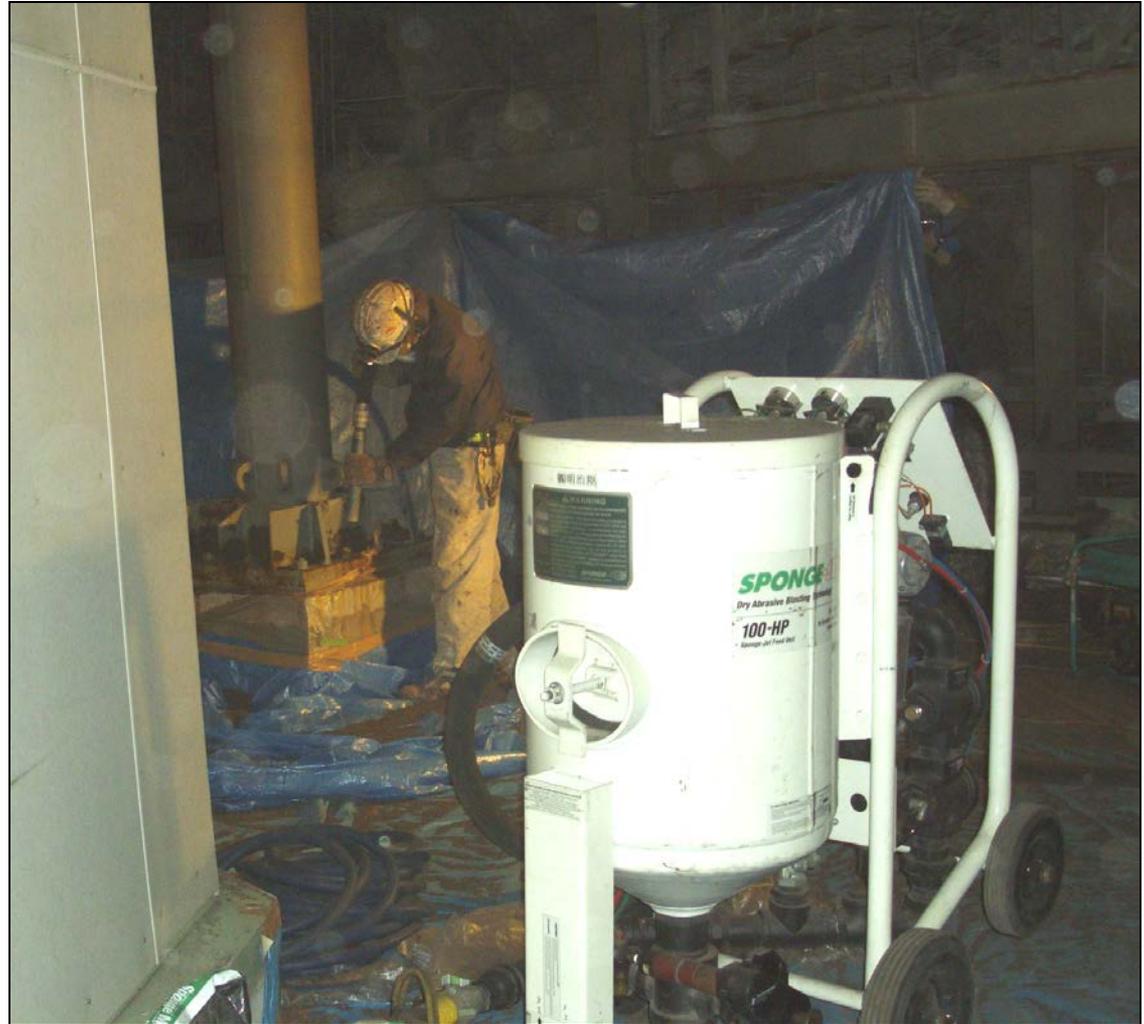
- Sponge Media could blast paint and rust completely in confined spaces (crevices)
- Sponge Media could achieve specification
- Superior profiled surface quality compared to other conventional abrasives

- 15 bags of Silver 30 and Silver 30DG Sponge Media™ abrasives
- 100-HP Feed Unit™  
35-P Sponge-Jet Recycler™

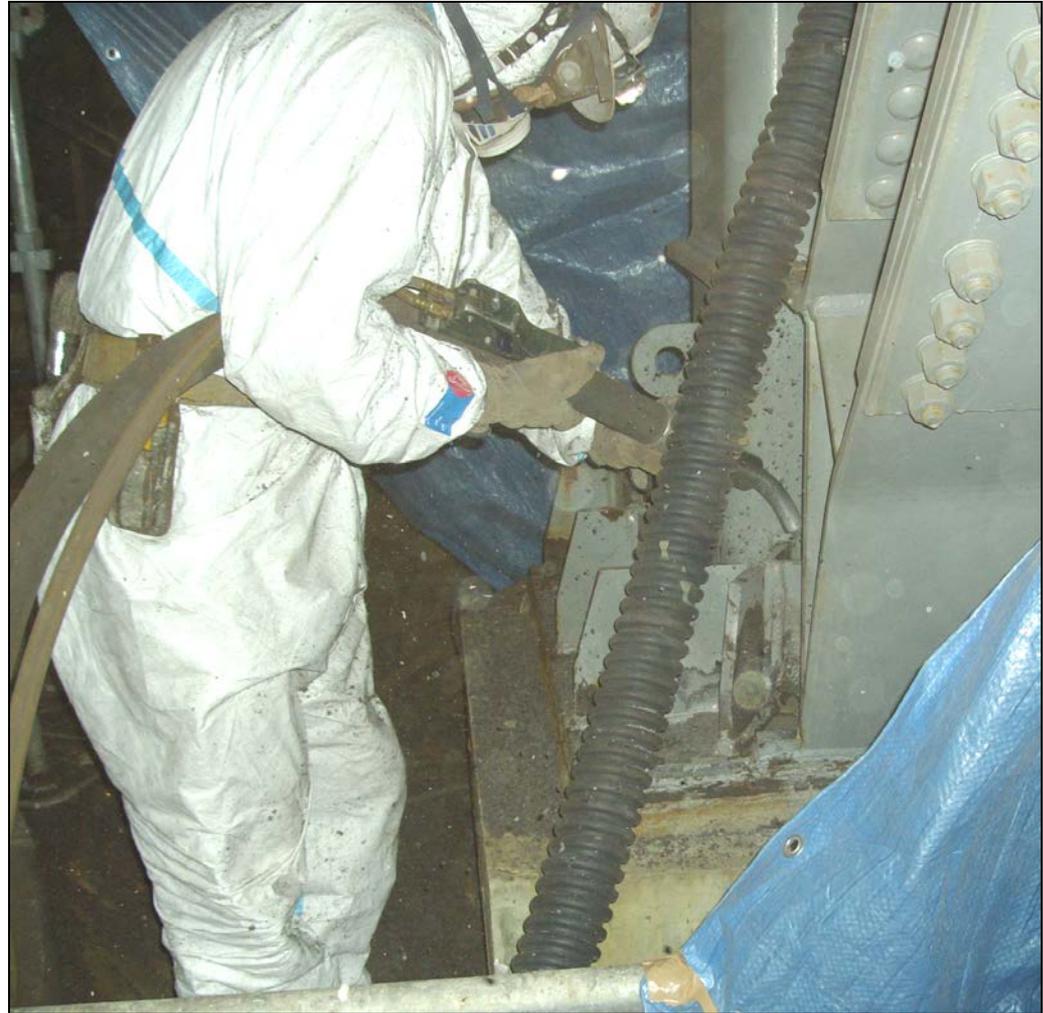
**SPONGE-JET BLASTER  
USING BANANA NOZZLE**

Customer reported that Sponge-Jet blasting was ten times faster than power tool preparation
