# Weld Seam Repair on a North Sea Offshore Oil Platform

*Platform manufacturer uses the Sponge-Jet® Sponge Blasting™ System to repair heat-affected weld seams with little impact on nearby activity or sensitive equipment*

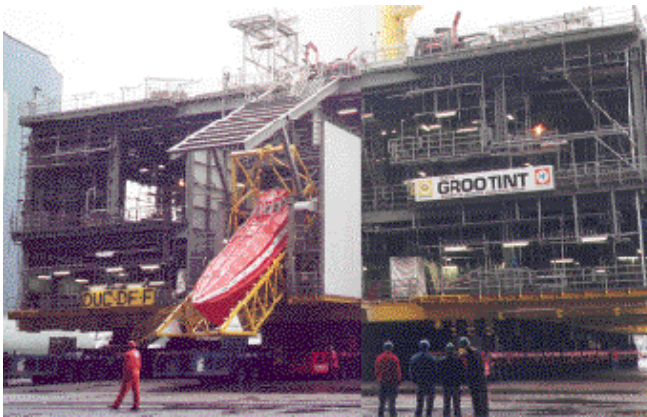
Coating engineers with a Netherlands manufacturer of offshore platforms searched for a method to repair weld seams. Welding, during assembly of the rig causes staining and damage to prepainted parts. Engineers wanted a repair process that would cause less damage to sensitive surrounding parts of the rig and equipment already in place. They chose Silver Sponge Media™ abrasives because of the following process characteristics:

Operators blasted six linear feet [2m] of weld seam per minute and removed the thick, charred, epoxy coating and inorganic zinc primer without damage to surrounding equipment, or interruption of nearby trades. In areas not exposed to rain, the contractor was pleasantly surprised to observe no flash rusting on three week old weld seams.
